Pavement Evaluation 2014

September 15 – 18, 2014
Resource International, Inc.

GPR for Pavement Rehabilitation

Premature Pavement Failure

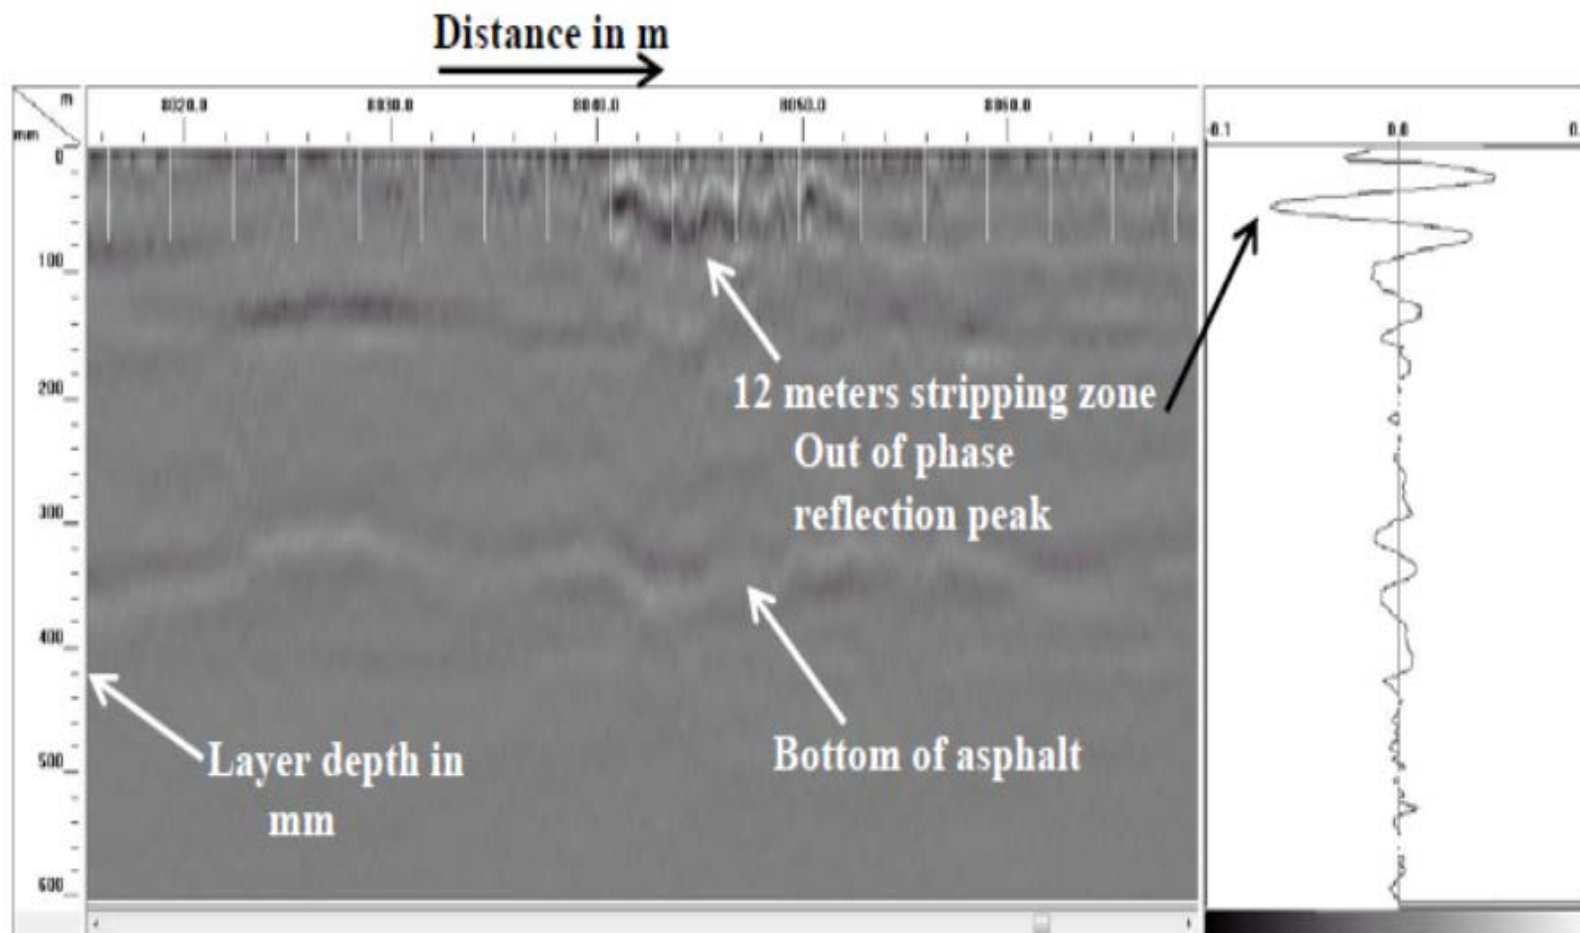
Figure 1. Detection of stripping

- Rii determined that the existing asphalt was severely stripped in many areas indicated by out-of-phase reflection peak
 - Radar wave travels from higher to lower dielectric material
 - Low dielectric a function of low density of the stripped material

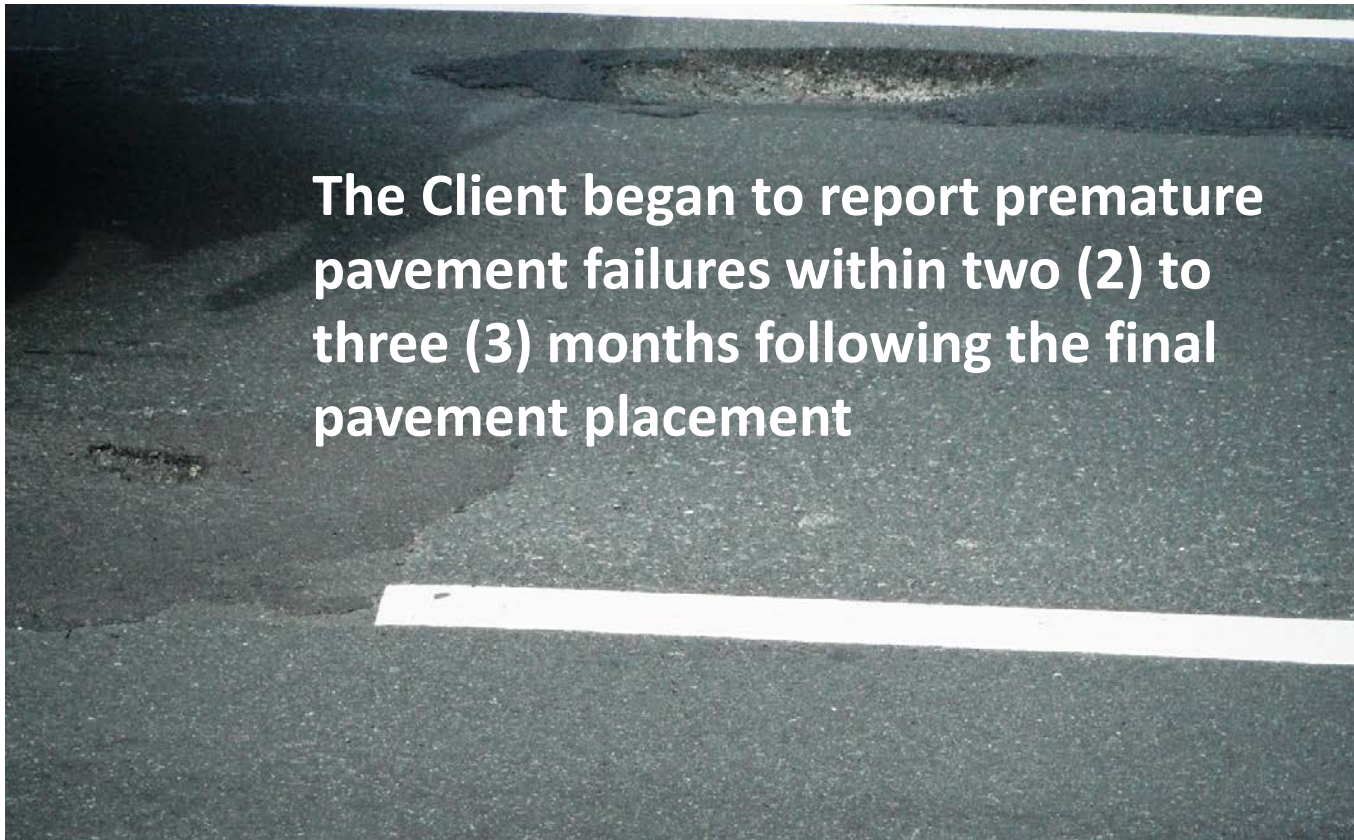
The Client began to report premature pavement failures within two (2) to three (3) months following the final pavement placement

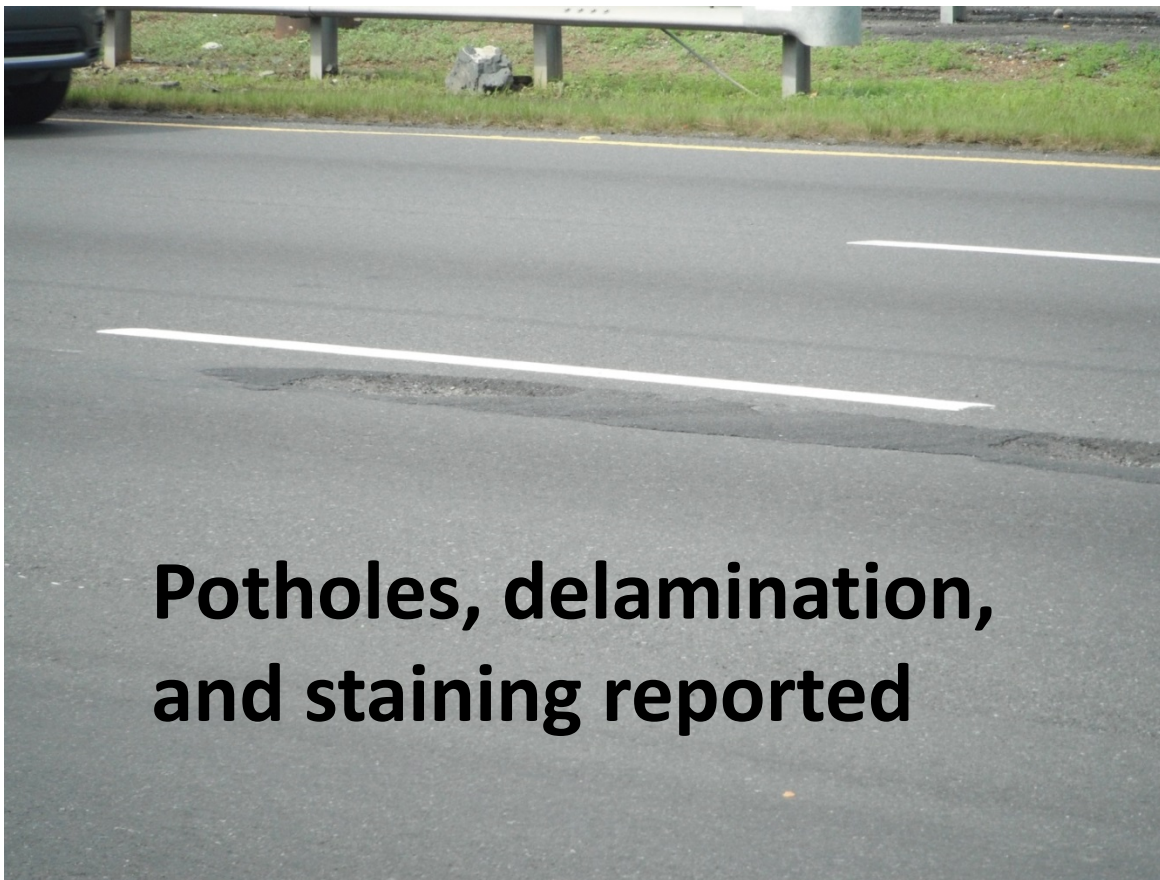
**Potholes, delamination,
and staining reported**

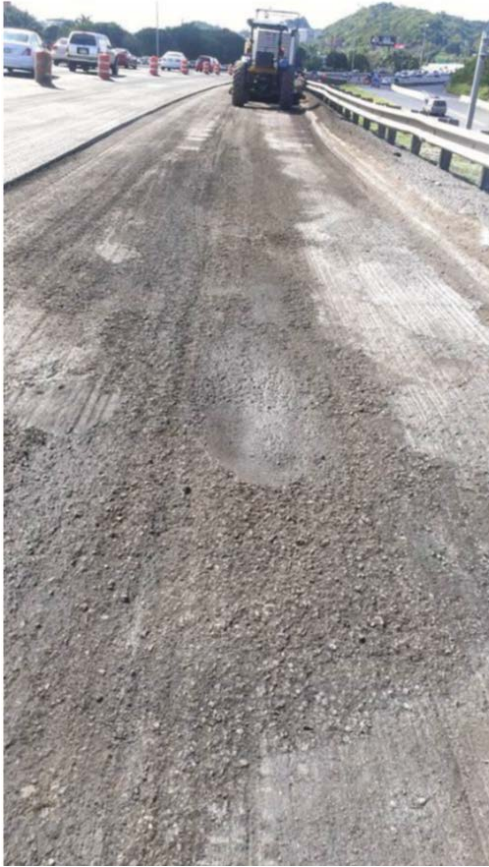
Suspect area after milling

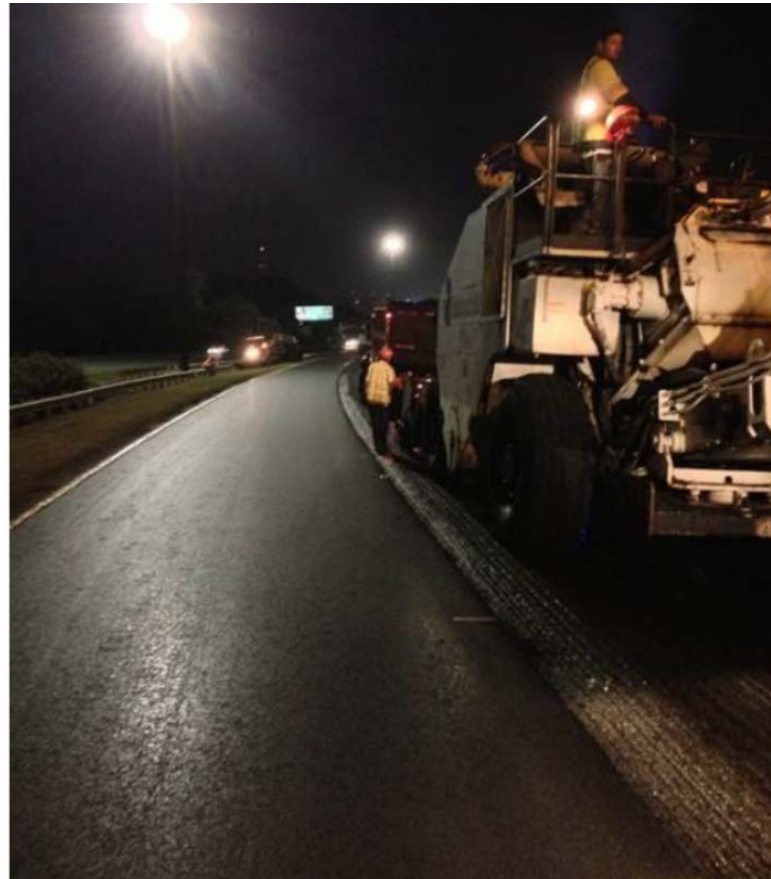
Typical night paving operation – note the paver tire track pick up

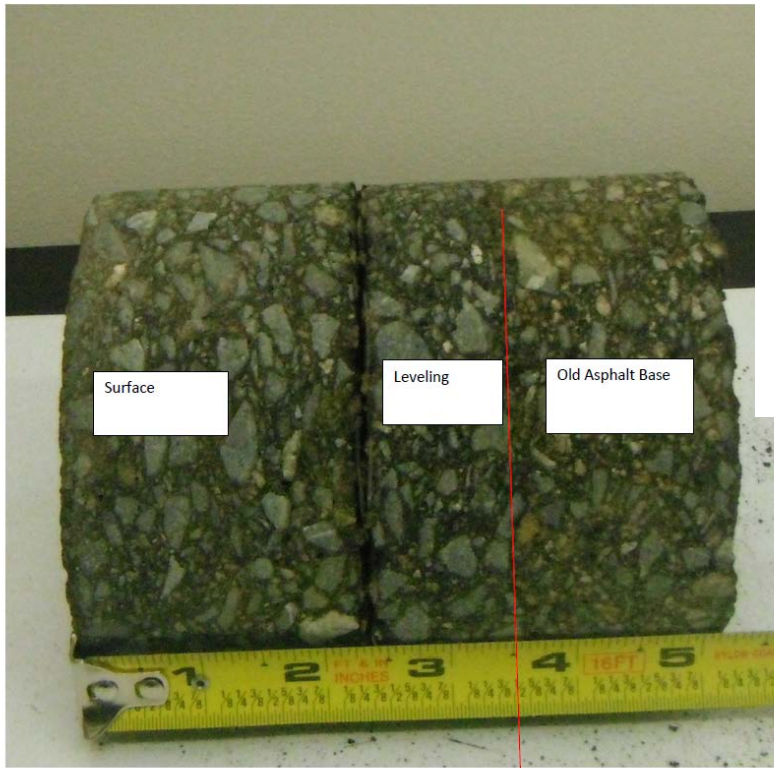
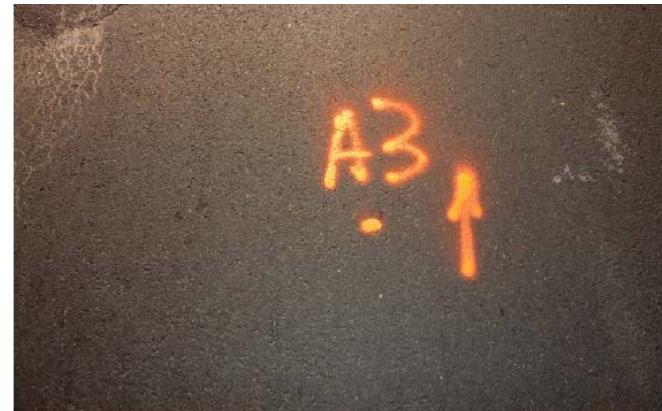
A-3

A. Area with visible distress at a relatively low pavement elevation area.

Cold mill to ~3" inches; ~1-inch WMA leveling course; geogrid; and ~2" inches of WMA surface course.

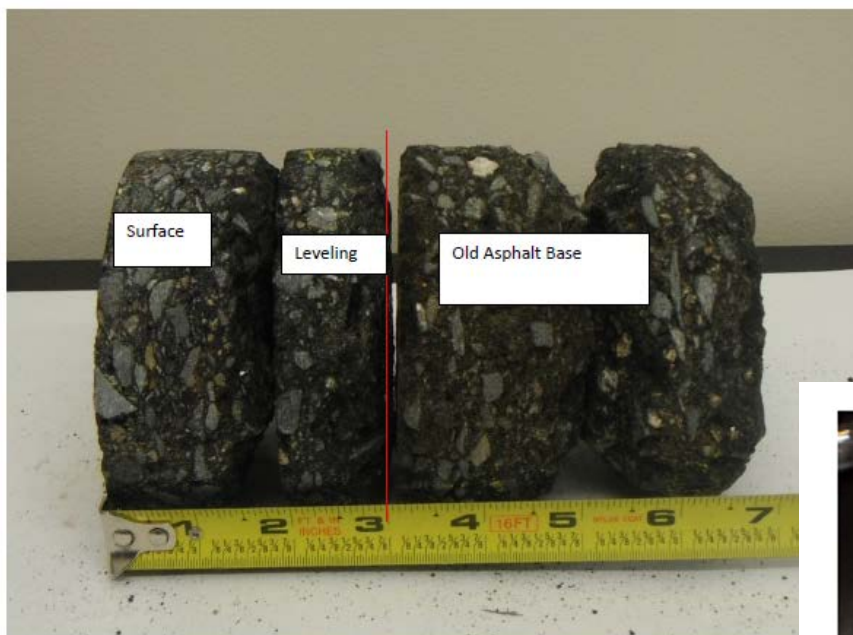
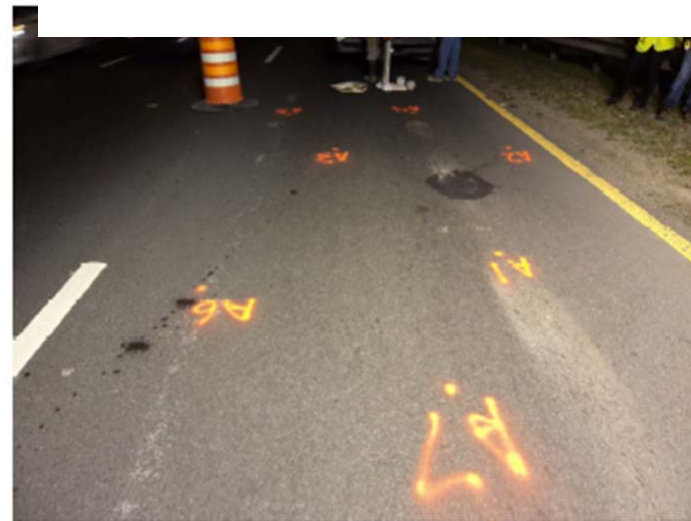
A-4

A. Area with visible distress at a relatively low pavement elevation area.

Cold mill to ~3" inches; ~1-inch WMA leveling course; geogrid; and ~2" inches of WMA surface course.

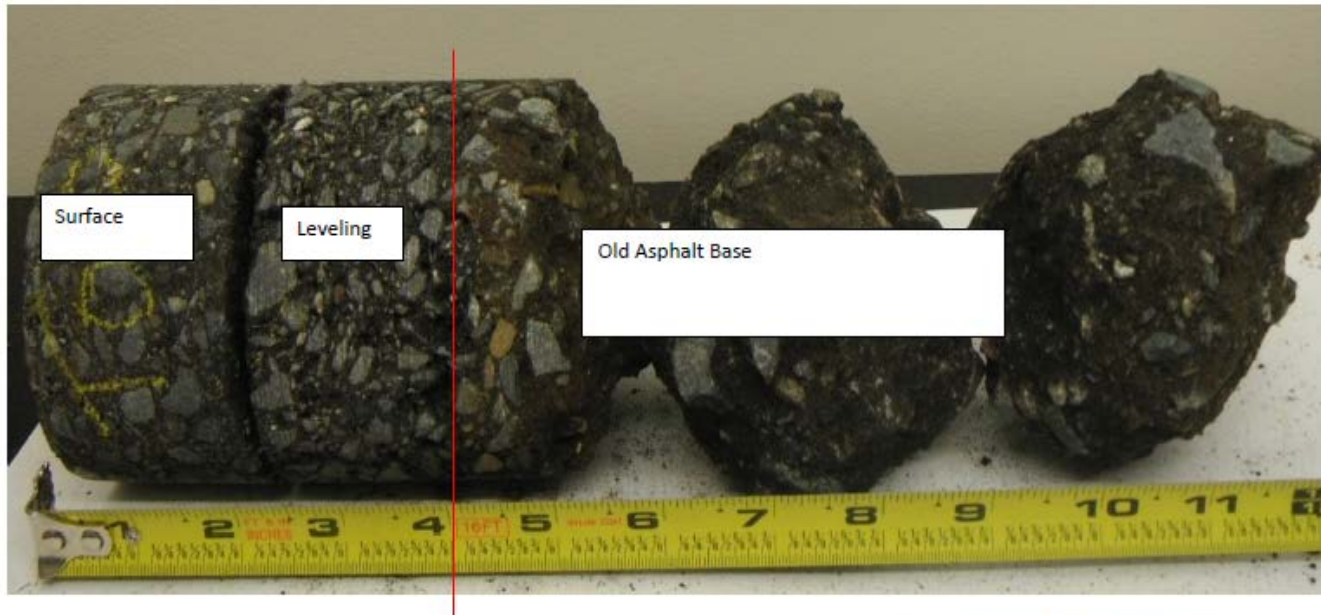
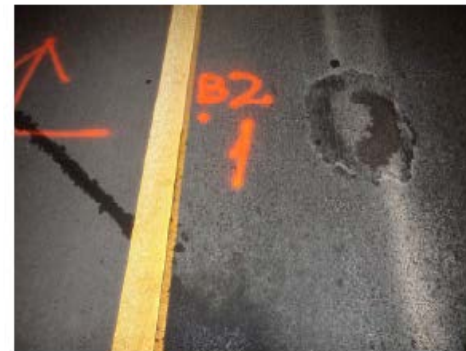
B-2

B. Area with visible distress at a relatively higher pavement elevation area.

Cold mill to ~3" inches; ~1-inch WMA leveling course; geogrid; and ~2" inches of WMA surface course.

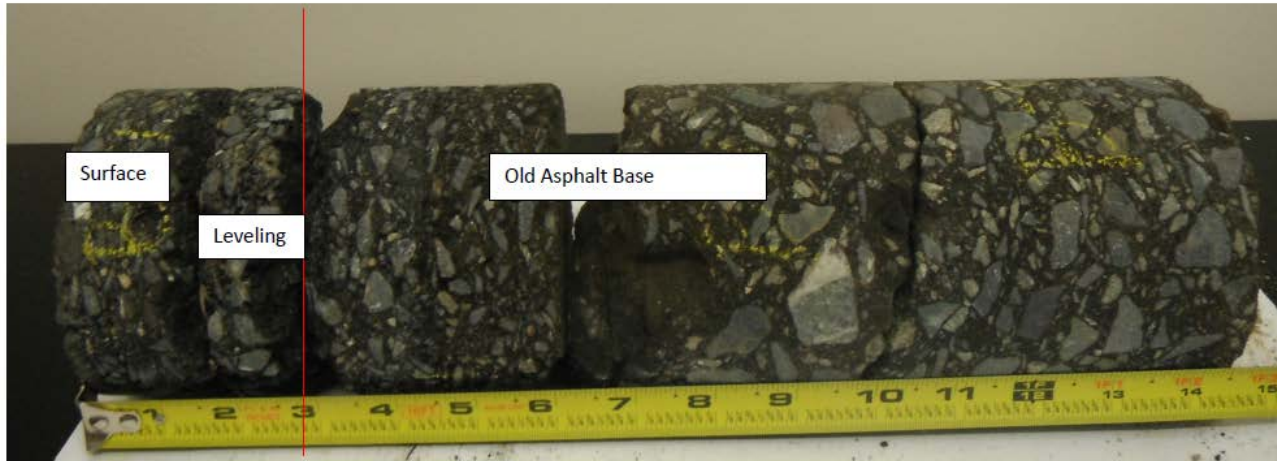
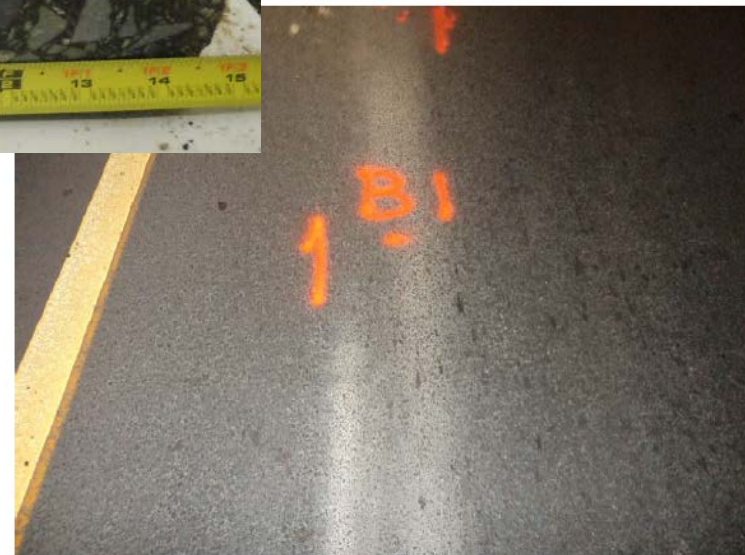
B-1

B. Area with visible distress at a relatively higher pavement elevation area.

Cold mill to ~3" inches; ~1-inch WMA leveling course; geogrid; ~2" inches of WMA surface course.

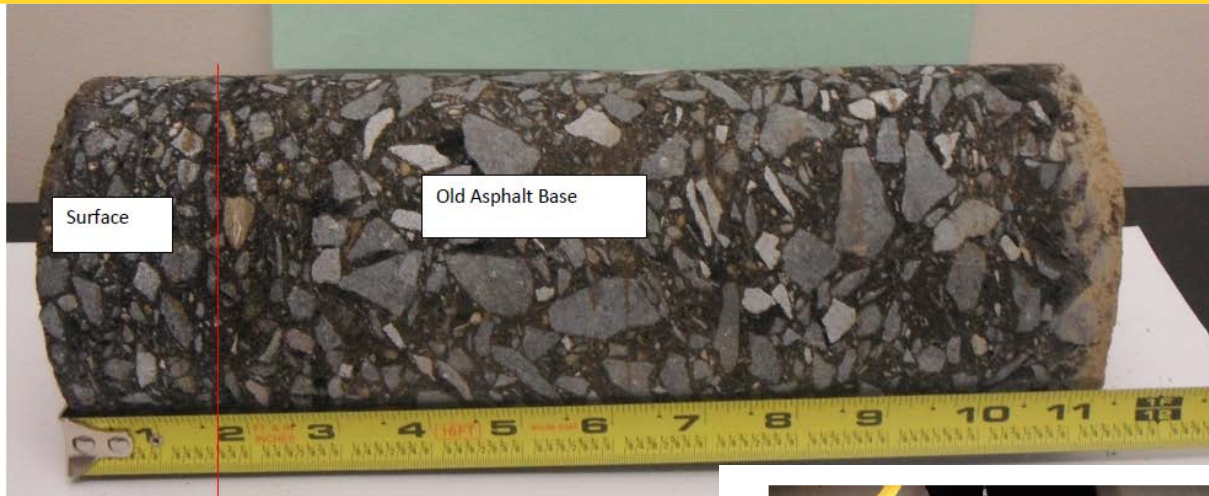
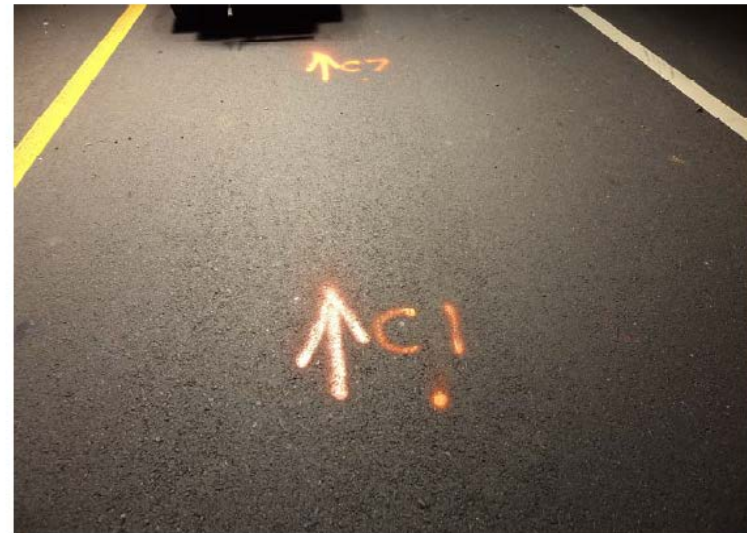
C. Area without visible distress.

Cold mill and place ~2" of WMA surface course.

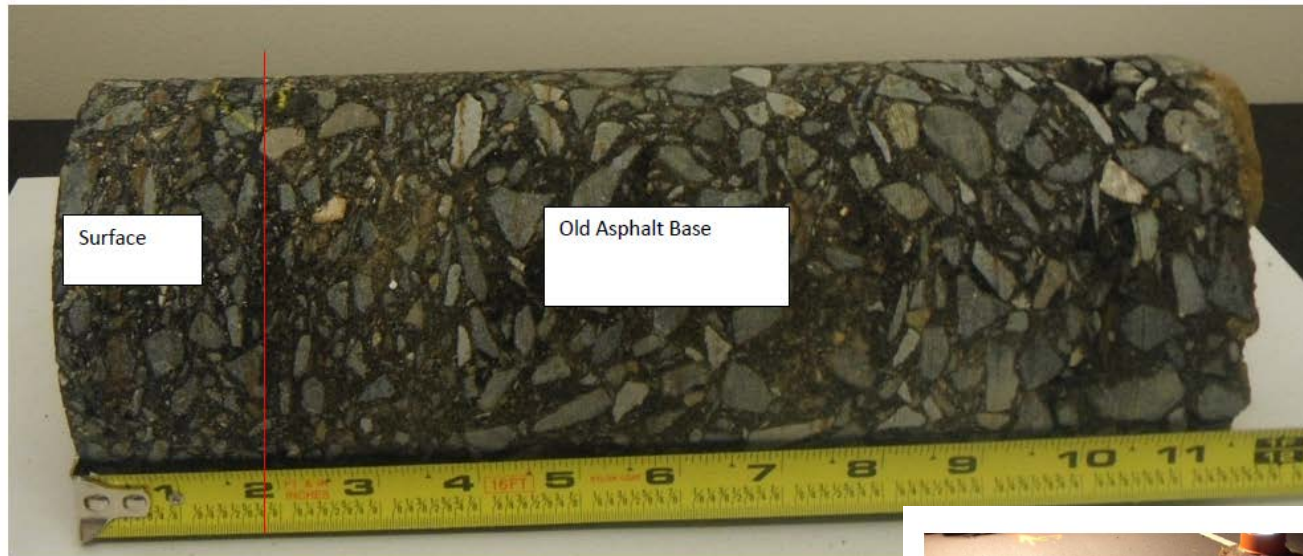
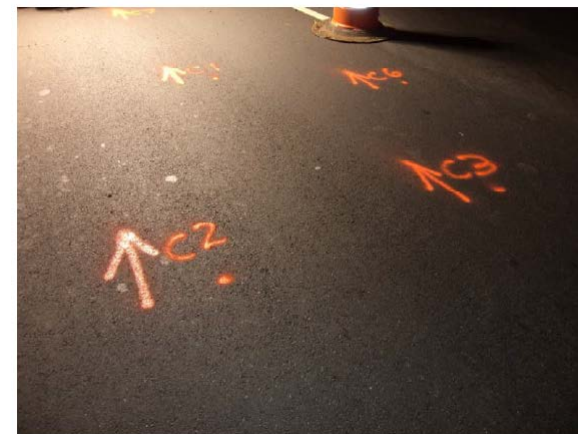
C-3

C. Area without visible distress.

Cold mill and place ~2" of WMA surface course.

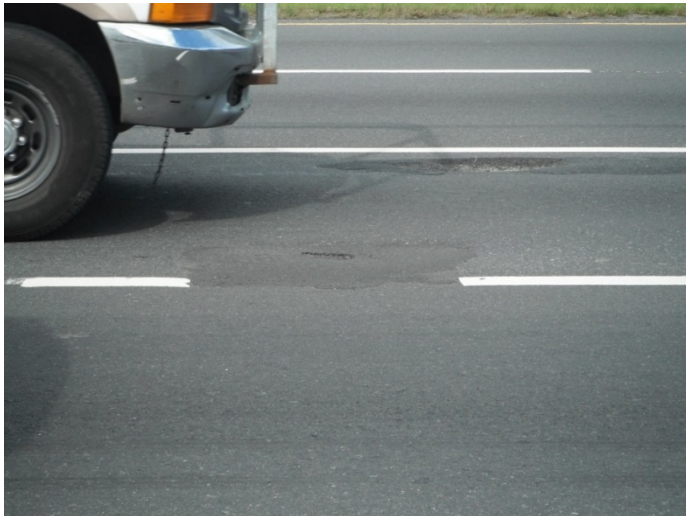
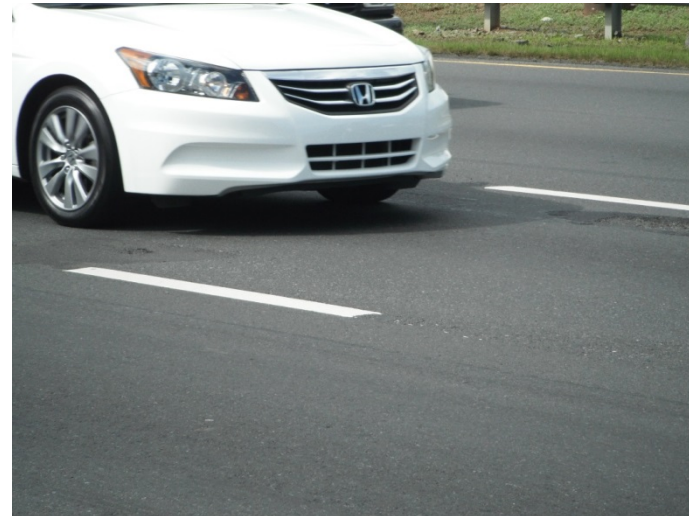
- Water entered old stripped asphalt matrix and was trapped when overlay was placed
- Trapped water can condense causing pressure in matrix in turn causing potholes in new asphalt course

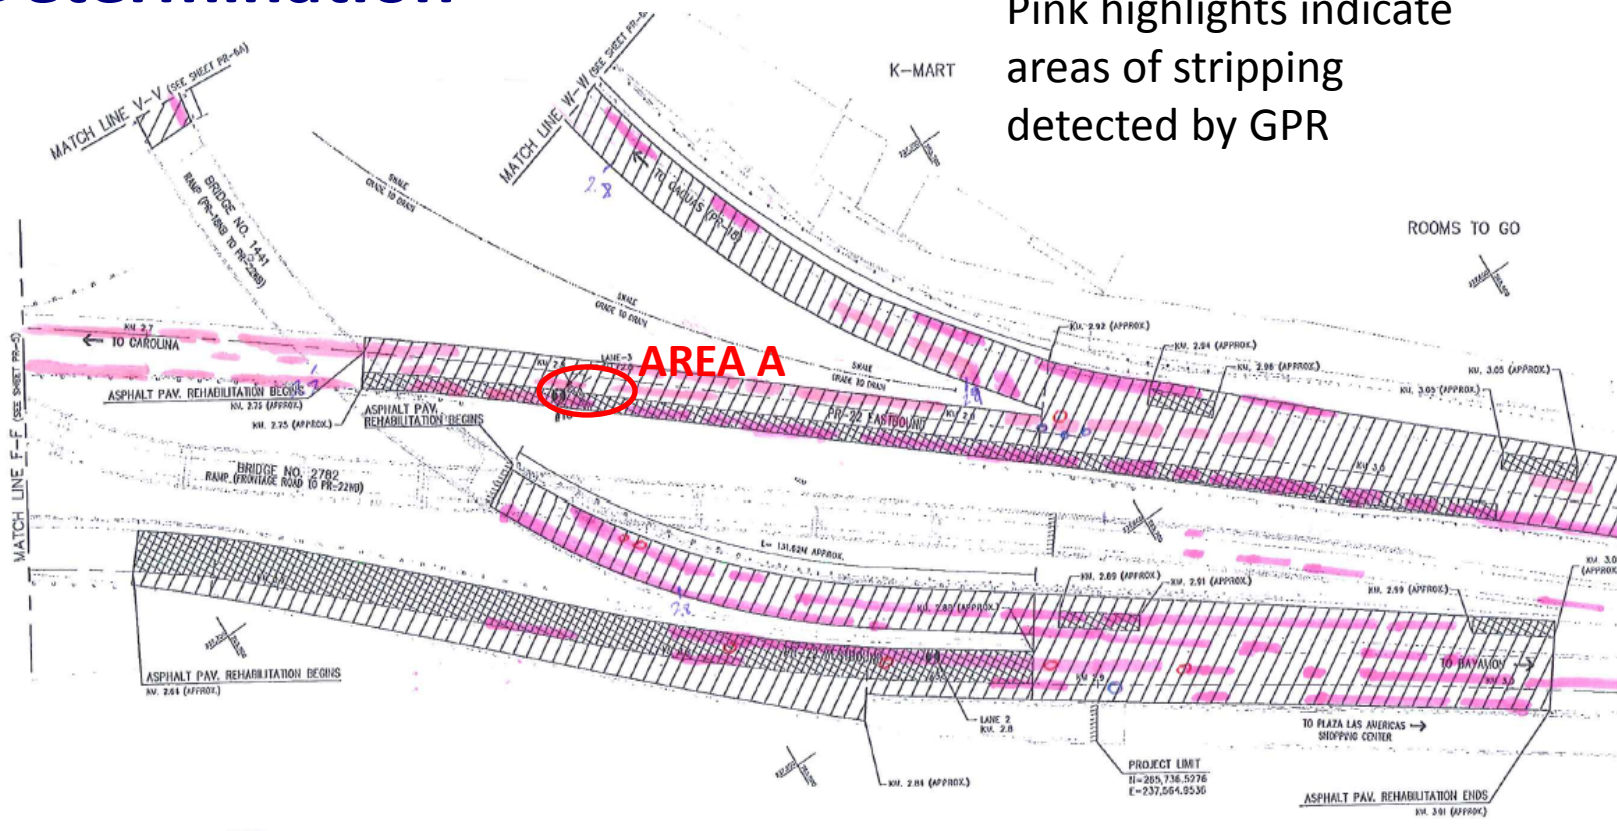
Pink highlights indicate areas of stripping detected by GPR

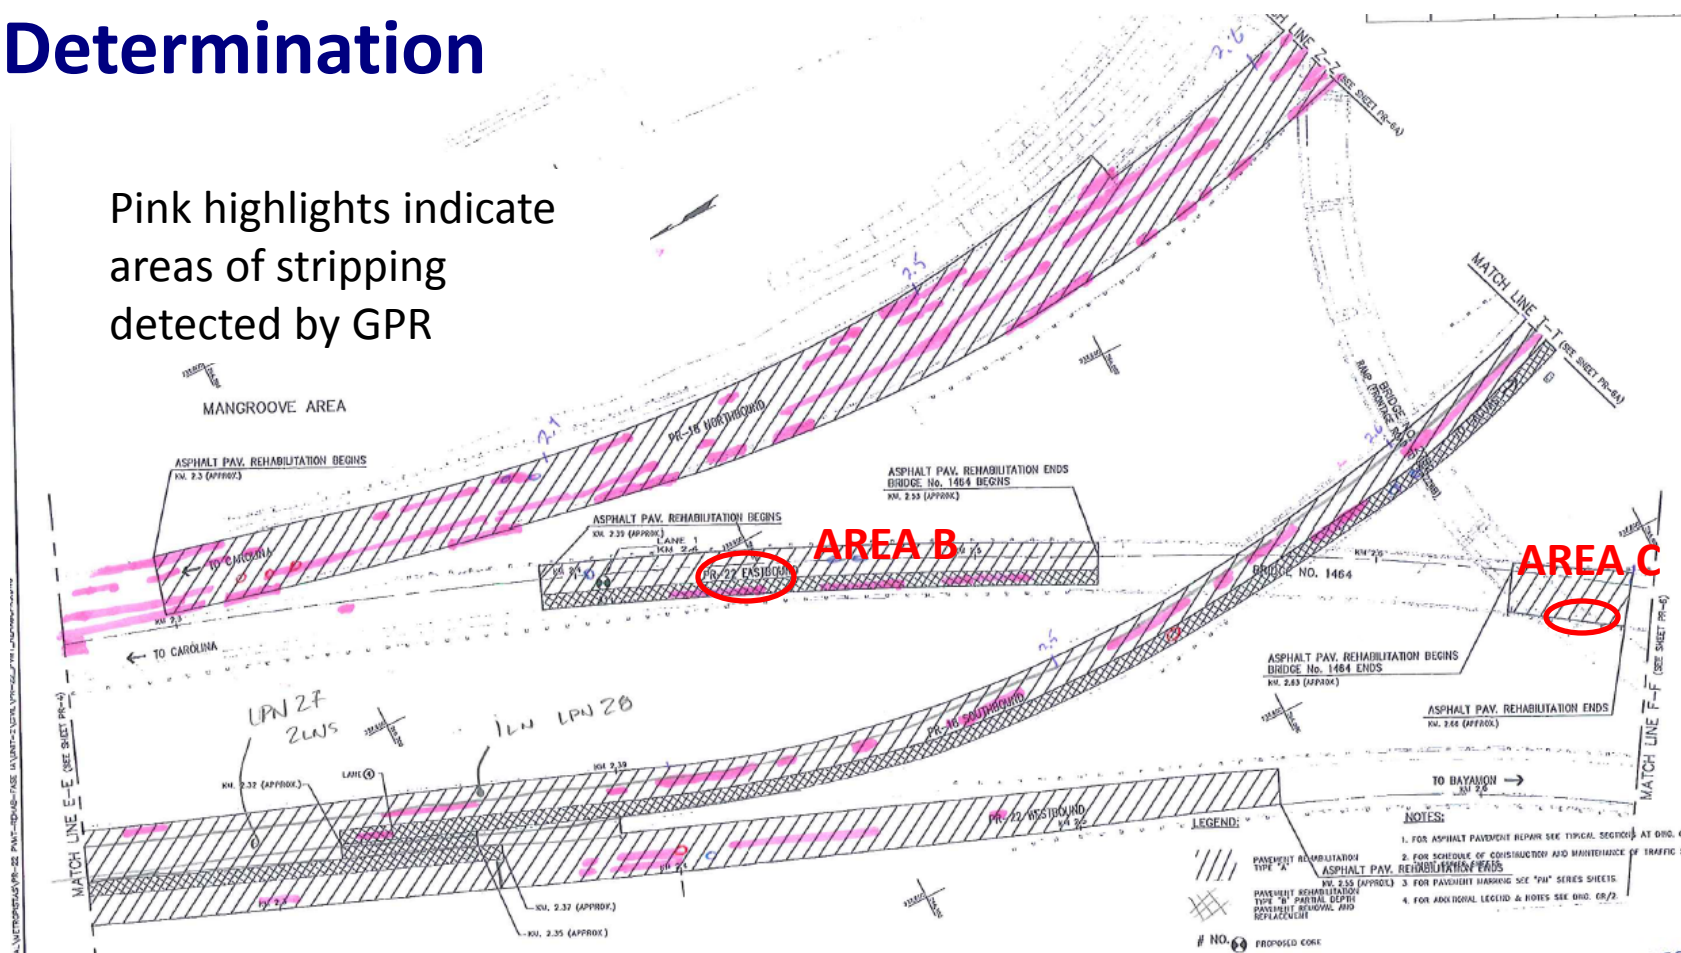
Pink highlights indicate areas of stripping detected by GPR

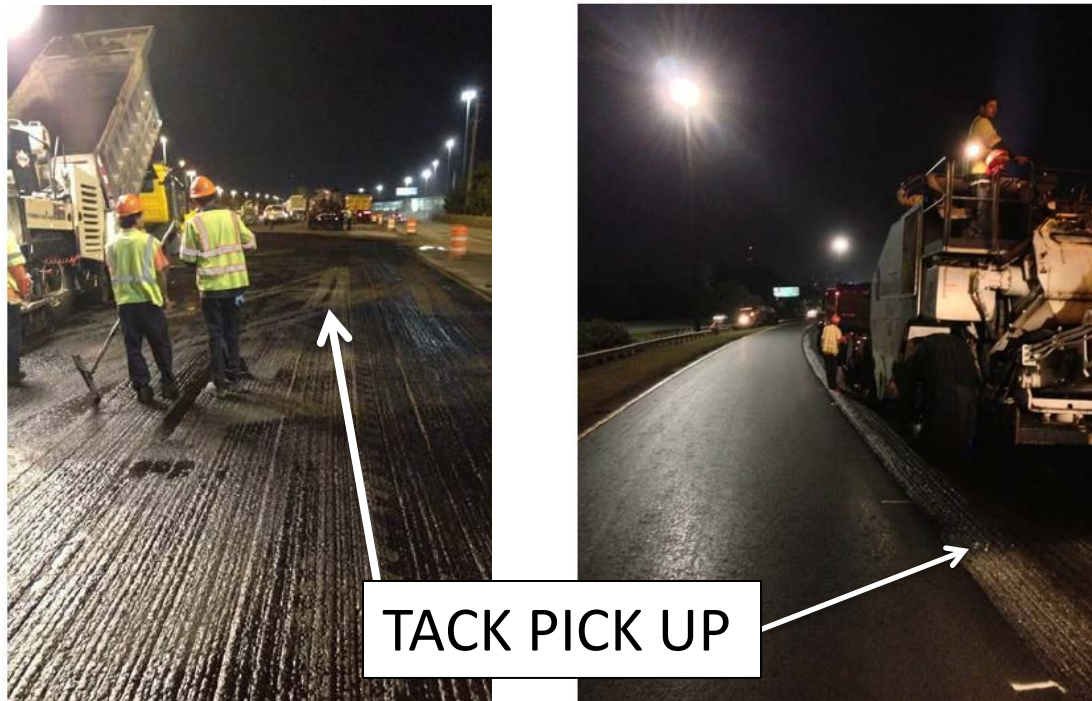
- Tack pick up during paving operation can contribute to pavement delamination
