# 9th International Conference on **MANAGING PAVEMENT ASSETS (ICMPA9)**

## Measuring Pavement Condition Data for a Long-term Pavement Performance Study on New Zealand Roads.

***D Brown***

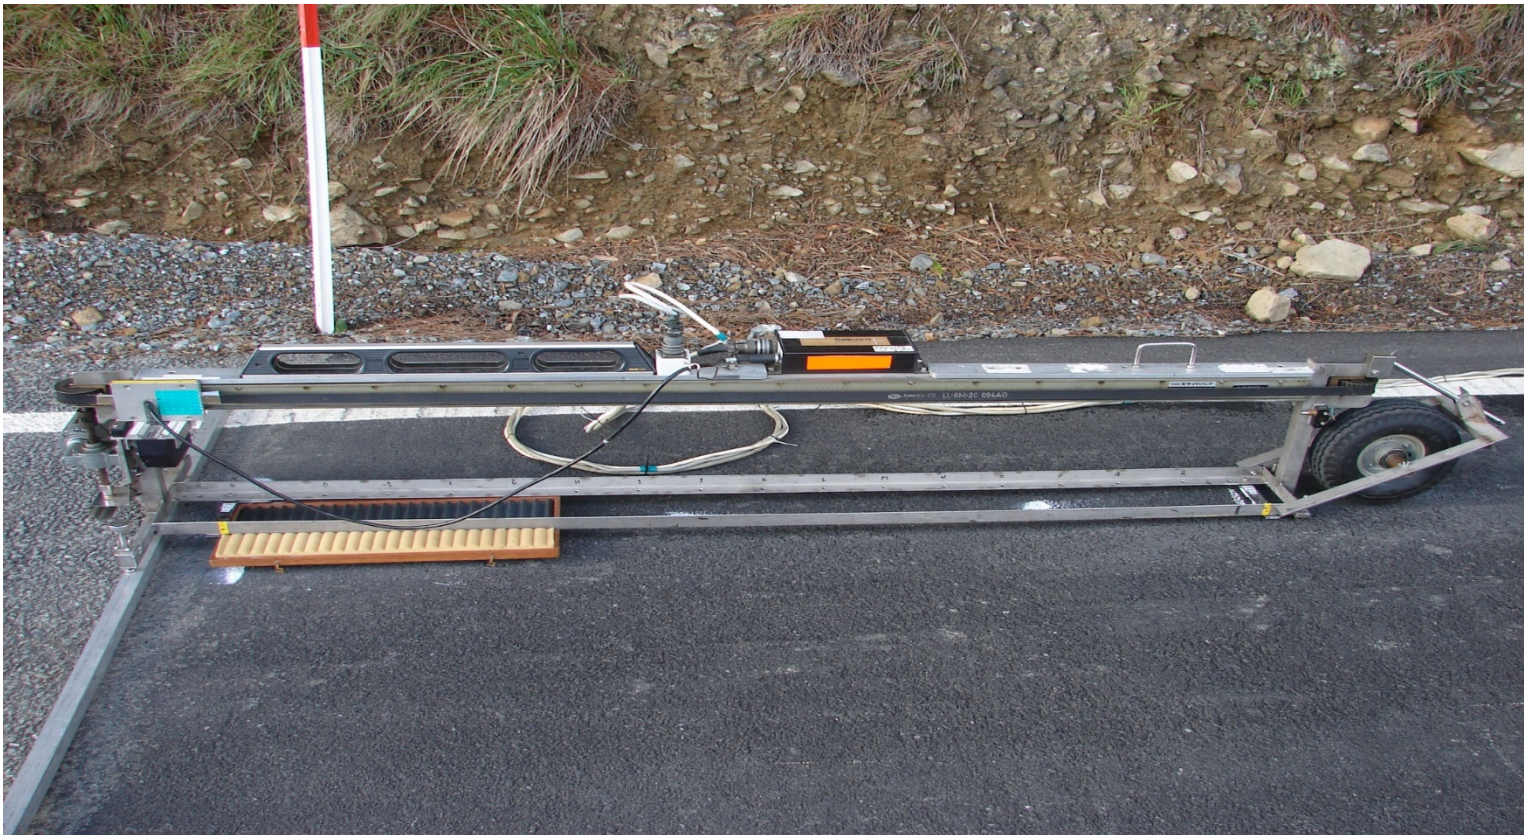
## Texture - Stationary Laser Profilometer

- Sites
  - 300m long
  - 2 lanes
  - Divided into 12 - 50m Subsections;
- Measurements
  - Roughness - ARRB Walking Profiler
  - Rutting - Transverse Profile Beam (R&D)
  - Texture - NZTA's Stationary Laser Profiler
  - Surface Distress - Visual Inspection
- Data Processing/QA

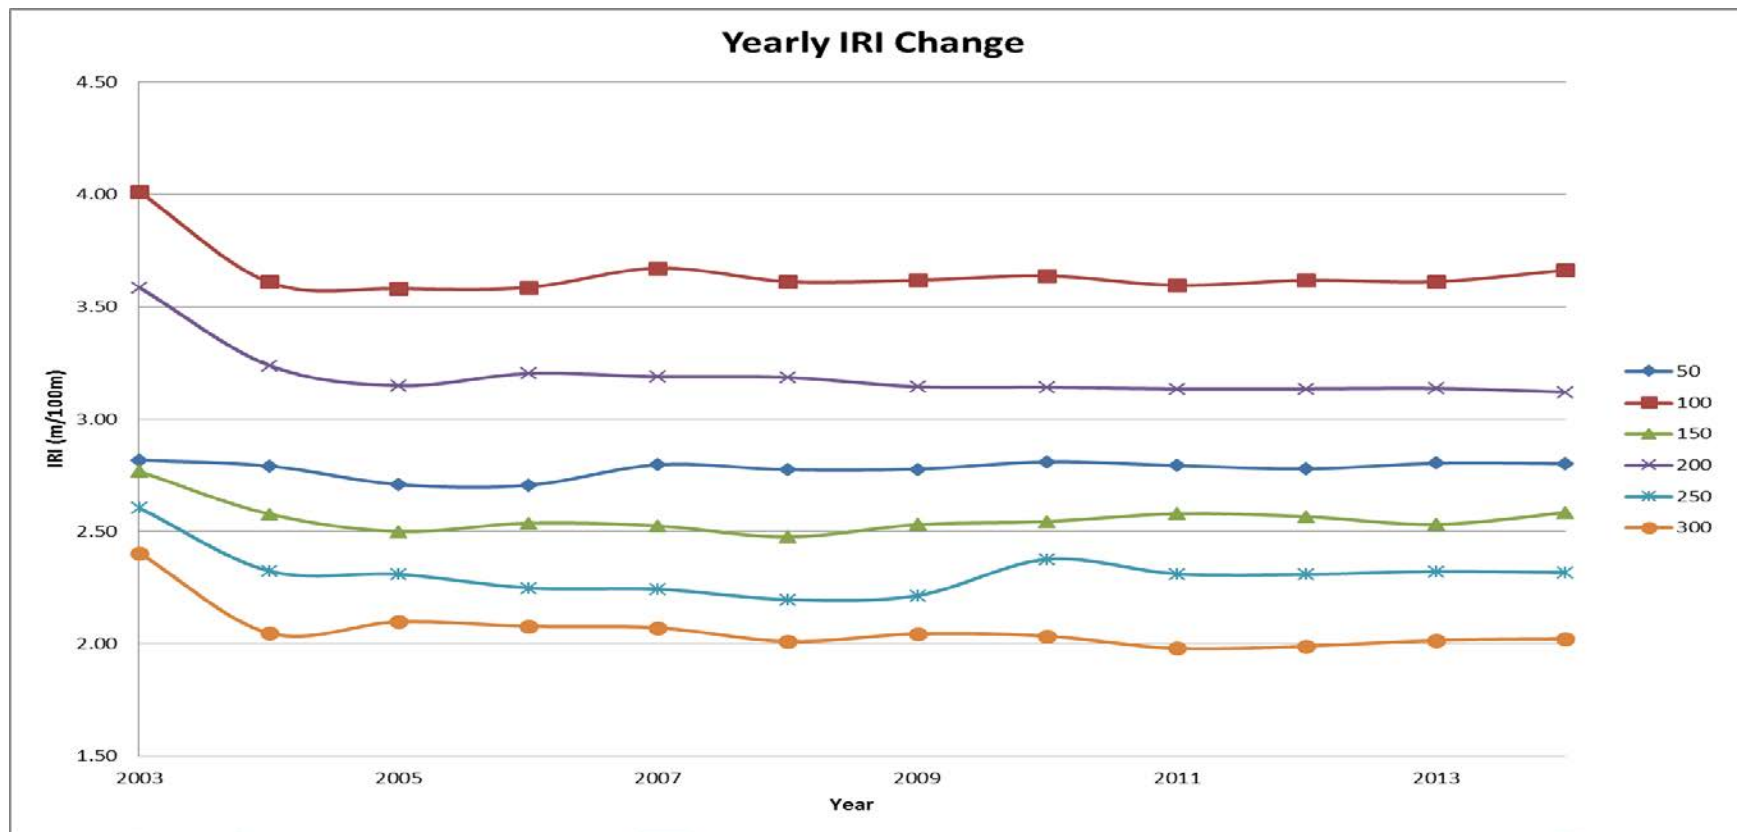
## 50m Roughness 2003 to 2014

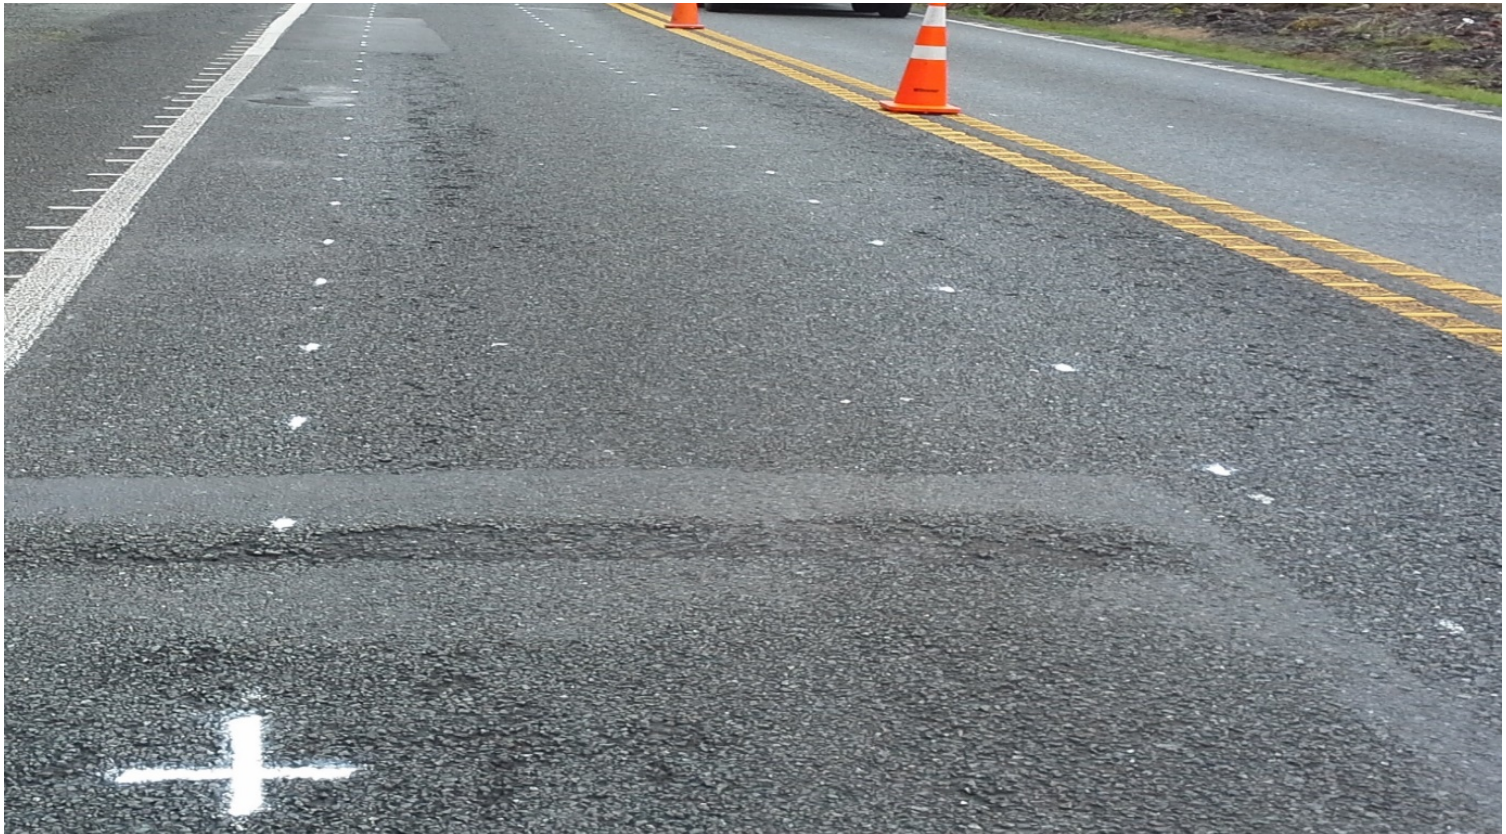
## Roughness Grade 3 Surface Treatment

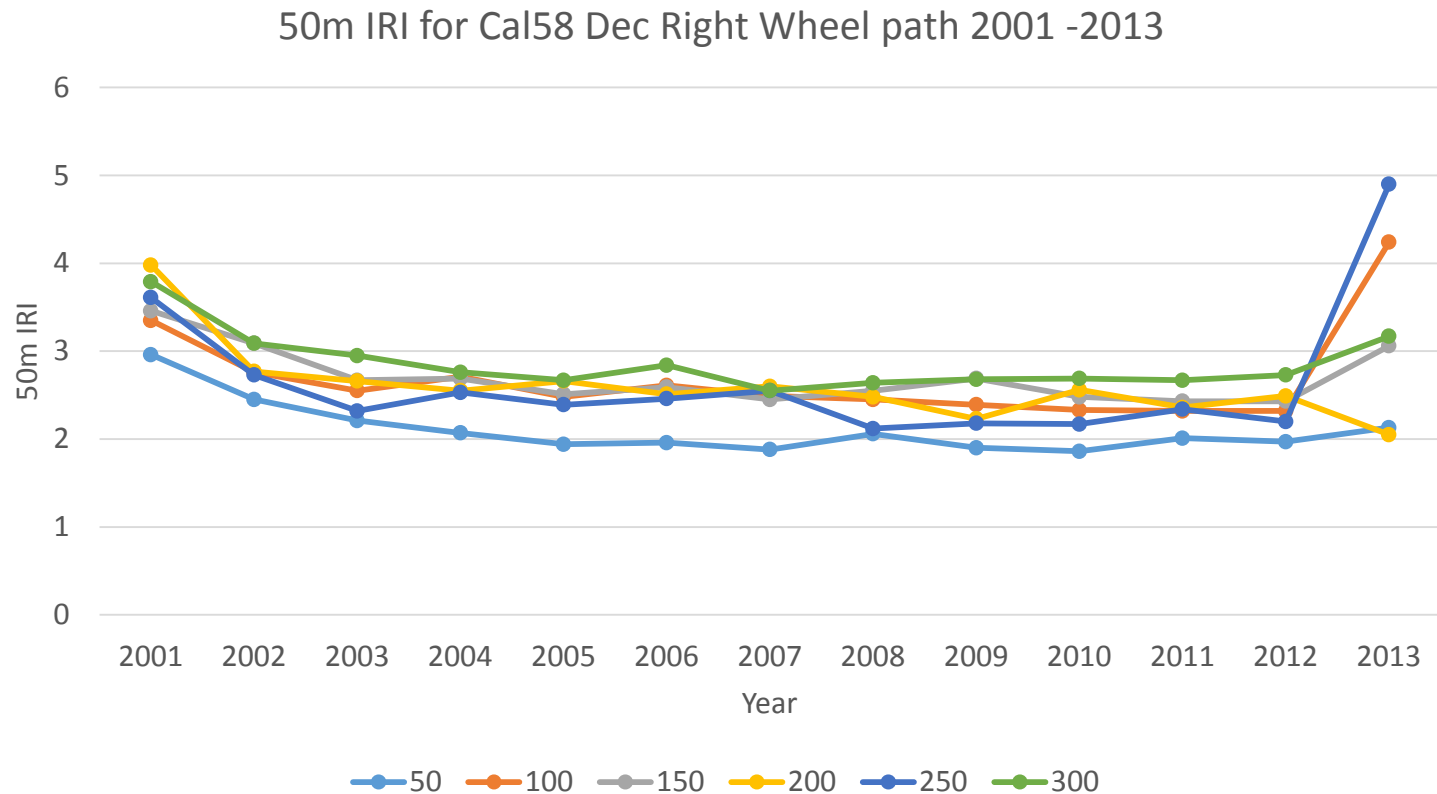
## Roughness G3/5 Surface Treatment

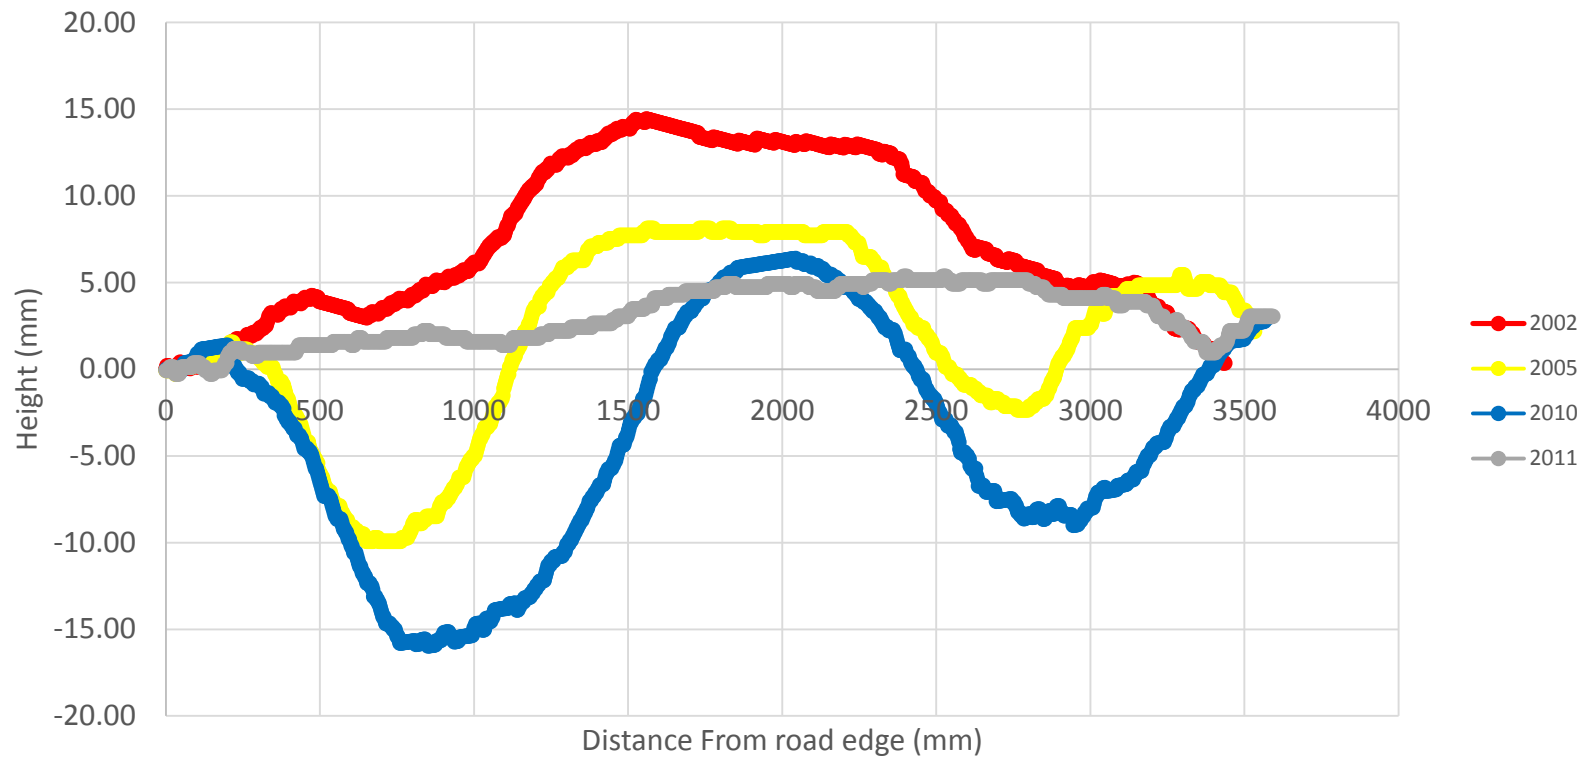
## Measurement Location - Rutting

Cs8B Transverse profile 2002, 2005, 2010 and 2011
