9th International Conference on
MANAGING PAVEMENT ASSETS (ICMPA9)

Recovering from the 2010 Nashville Flood

Pavement Management as a Tool in Long Term
Disaster Recovery

Donald Reid, Metro Nashville Public Works
Jacob Walter, Applied Research Associates

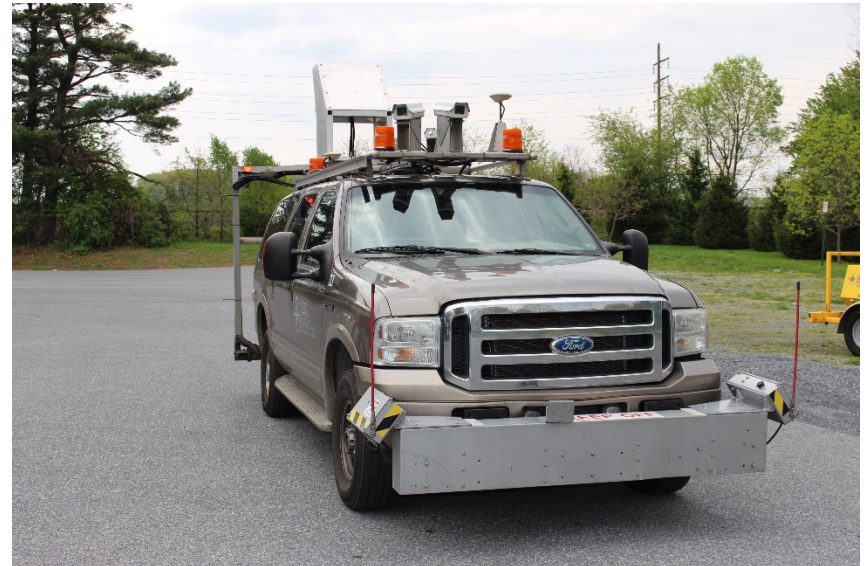
Evaluating Condition

- Used a digital survey vehicle from ARA
- Evaluate ½ of network every year
- Collect imagery, location, and laser-based data

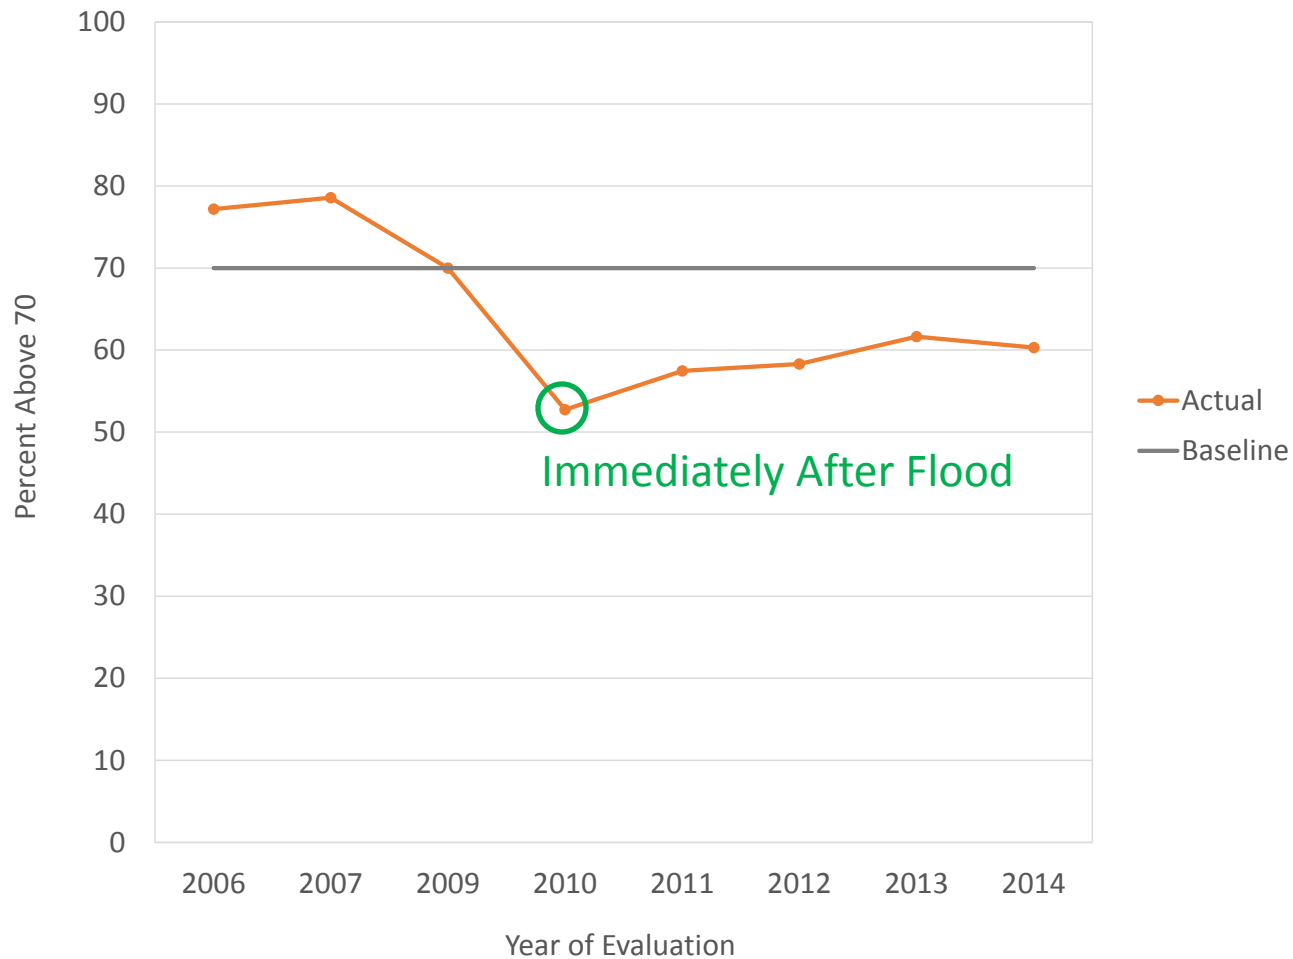
Network Health Before & After

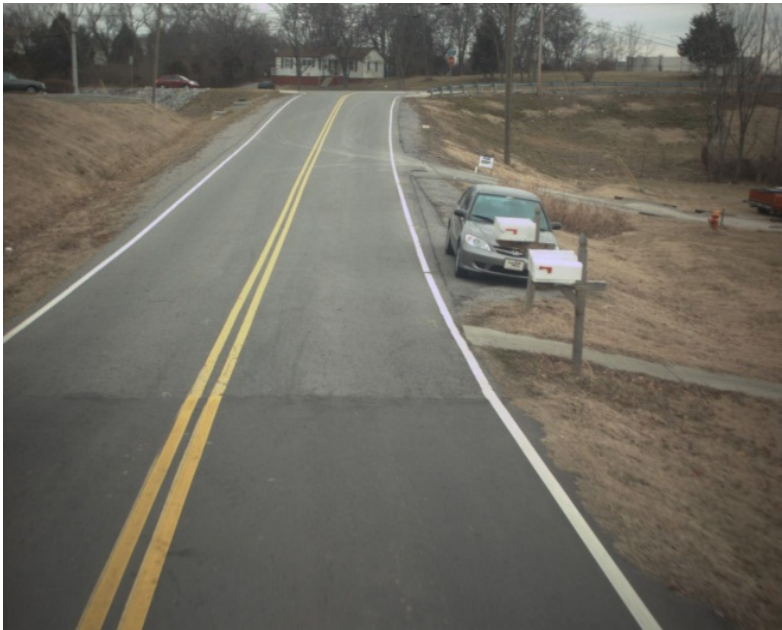
2008

Evaluating the Problem

- We also examined imagery

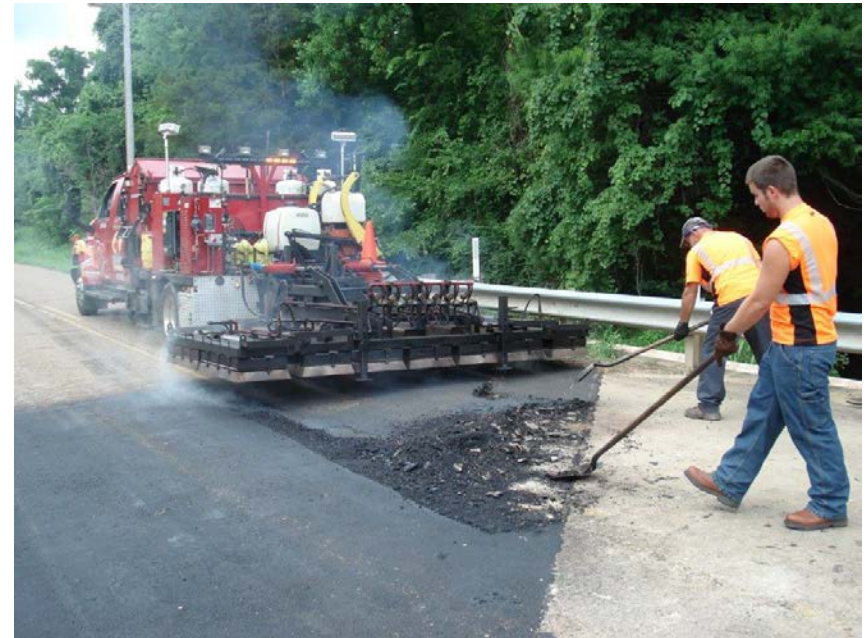
Repair Approach

- Base Failures – Full Depth Reconstruction
- Potholes – Infrared Patching

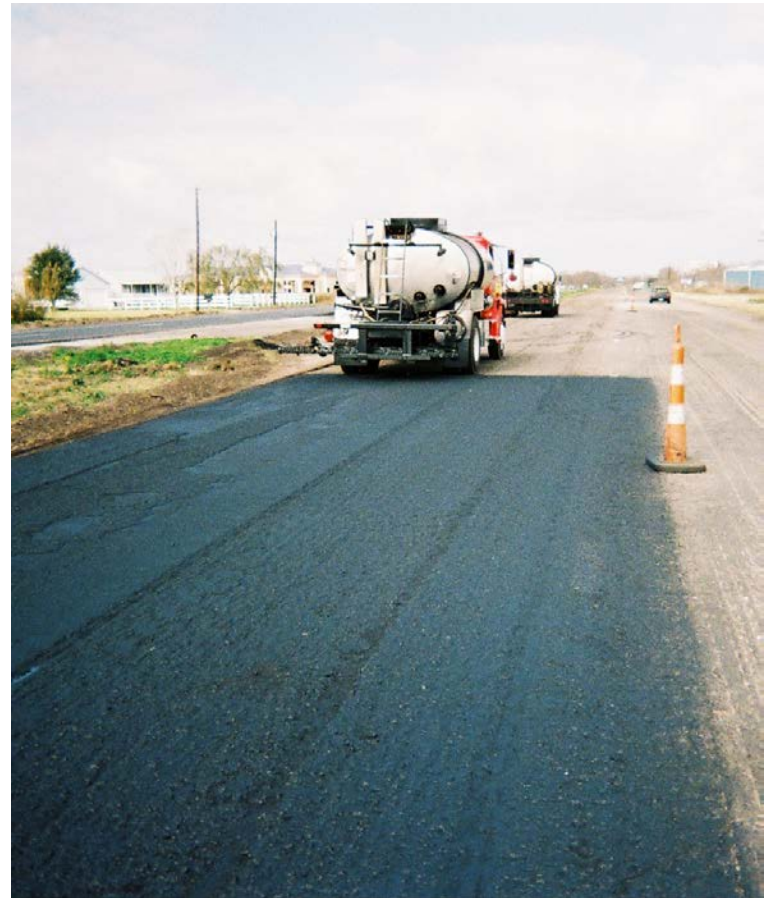
Construction Approach

- Most potholes were the result of delamination between base and surface asphalt
- New specifications required a new trackless tack product to increase shear strength between asphalt layers
