## Damage Assessment of Existing Asphalt Pavements for Mechanistic-Empirical Rehabilitation Design in Virginia: a Hybrid Approach

By: Jhony Habbouche, Ph.D.

Virginia Transportation Research Council Charlottesville, VA, 22903

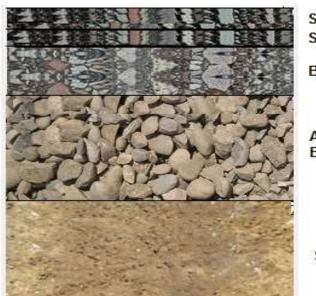
SM-12.5D; 2.0 inch SM-9.5D: 1.6 inch

BM-25.0A; 4.7 inch

Aggergate Base 21A; 6.0 inch

Subgrade

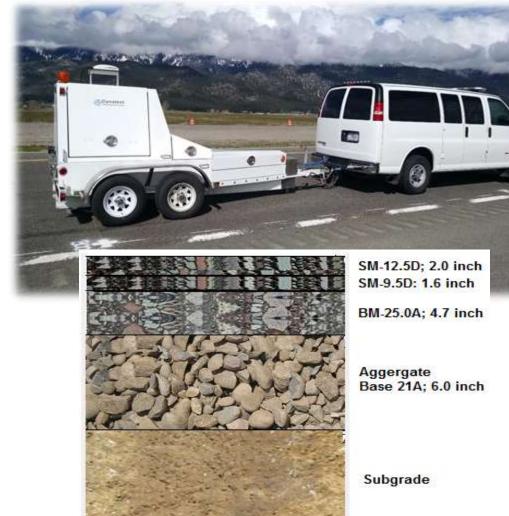
## Damaged Dynamic Modulus: FWD Testing

Modulus of existing AC layer obtained from FWD testing				
FWD Modulus (ksi) Frequency (Hz)		Temperature (°F)		
750	15	88

- Should existing AC layers be characterized separately?
- Can the AC layers be separated during the FWD analysis?
- How existing AC layers will be modeled in Pavement ME?

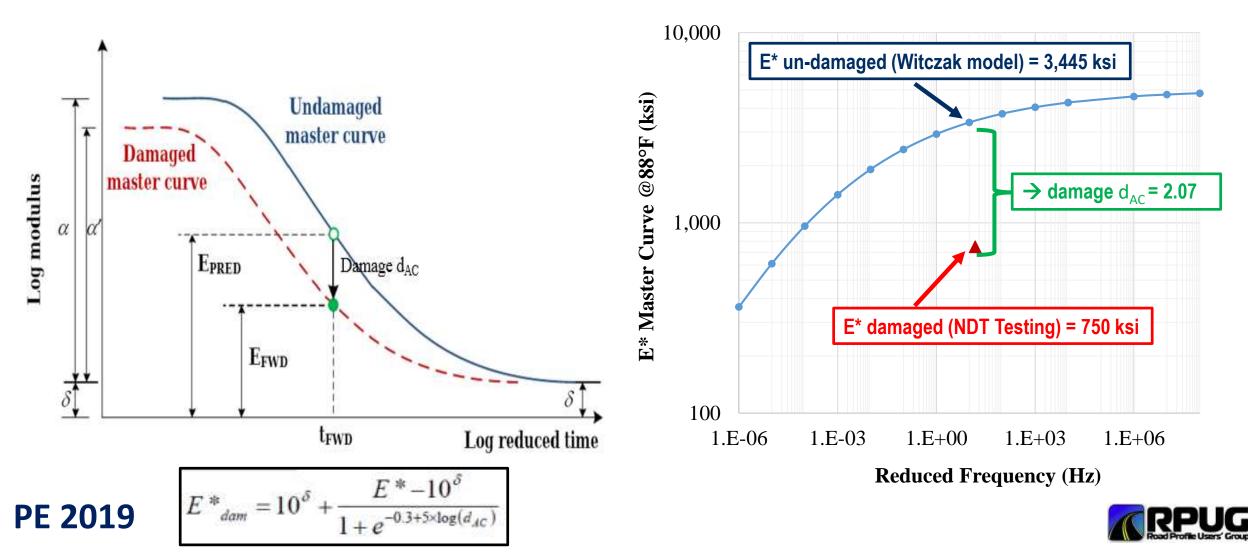
## Damage Characterization Based on MEPDG Approach (Estimation of FC Damage)

□ Using Witczak model E\*(undamaged) & FWD E\*(damaged): 2.07

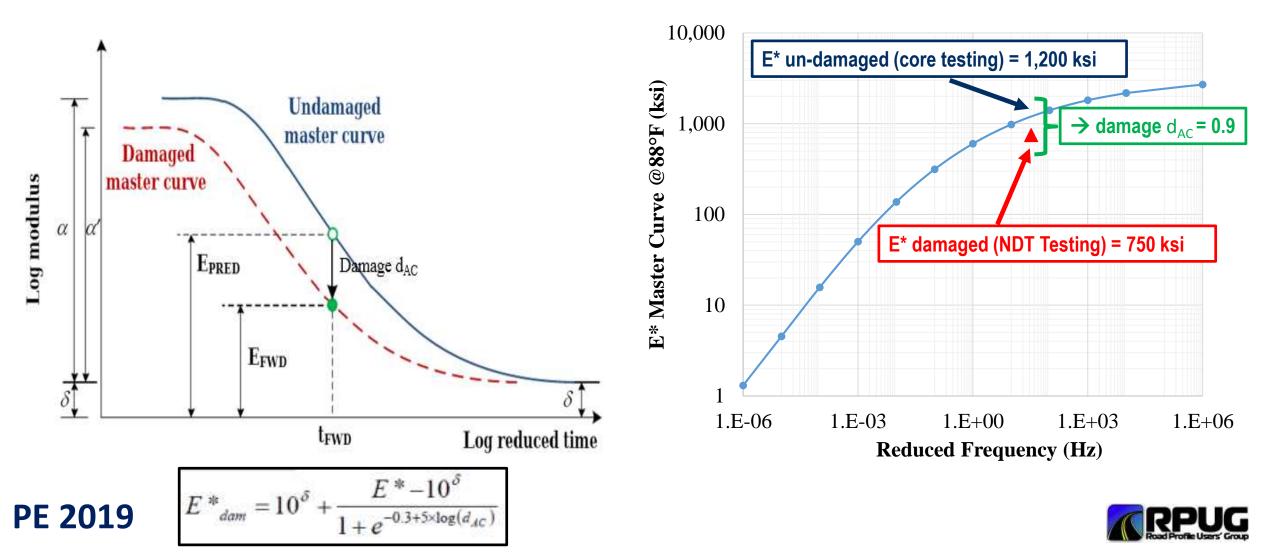
## Damage Characterization Based on HYBRID Approach (Estimation of FC Damage)

□ Using E\*(undamaged) of cores tested in the lab & FWD E\*(damaged): 0.9

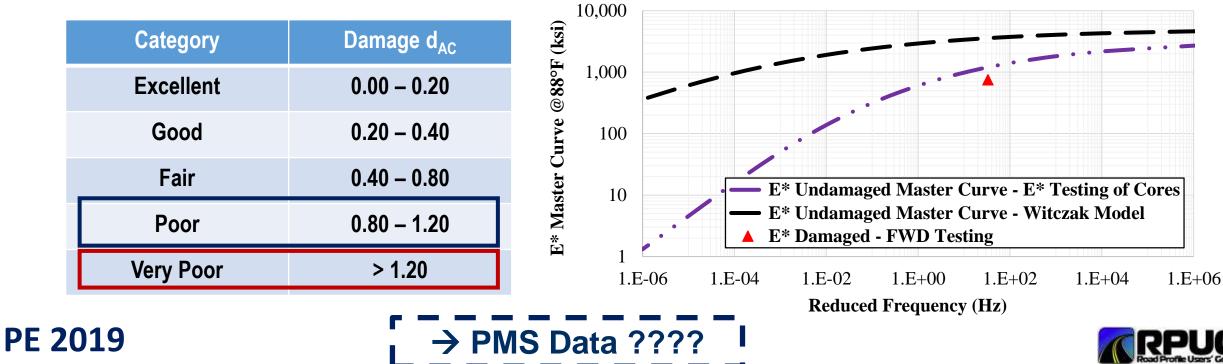
# FC Damage Characterization: *MEPDG* vs. *Hybrid* Approach

• Estimated Damage **d**<sub>AC</sub>:

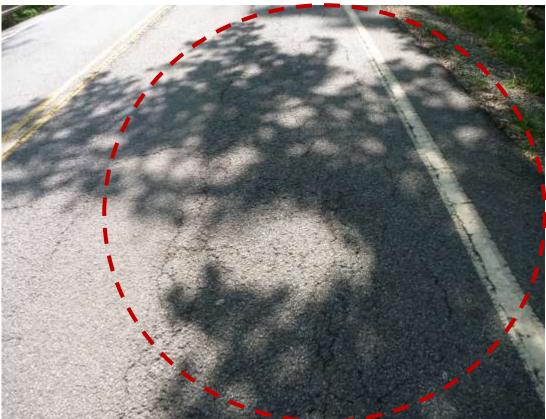
# Percent Alligator Cracking: *MEPDG* vs. *Hybrid* Approach

$$FC_{Bottom} = \left(\frac{1}{60}\right) * \left(\frac{C_4}{1 + e^{(C_1 * C_1^* + C_2 * C_2^* * \log(d_{AC-Bot} * 100))}}\right)$$

- FC<sub>Bottom</sub> = Area of alligator cracking, % of total lane area;
- d<sub>AC-Bot</sub> = cumulative damage index at the bottom of AC layer;
- $C_1 = 0.8$ ;  $C_2 = 0.8$ ; and  $C_4 = 6000$
- C\*1=-2\*C\*2
- C\*<sub>2</sub>=-2.40874-39.748\*(1+h<sub>AC</sub>)^(-2.856)

Parameters / Approach	MEPDG	HYBRID	<b>PMS Data (2014)</b>
	Damage d <sub>AC</sub>	2.07	0.9	0.7
PE 2019	Area of Alligator Cracking	<b>65.2%</b>	( 47.9%	42.2%
