Performance of High Friction Surfacing Demonstrations in the U.S.

7th Symposium on Pavement Surface Characteristics 19 September 2012

FHWA Surface Enhancements At Horizontal Curves (SEAHC) Program

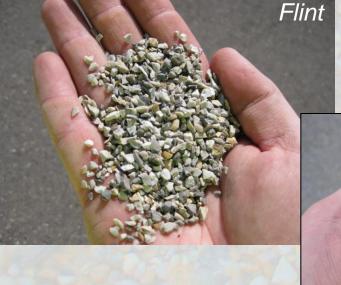
- Generally calcined bauxite or flint, but slags, granite, and other materials with high PSV have also been used
- Generally 3-4 mm maximum size

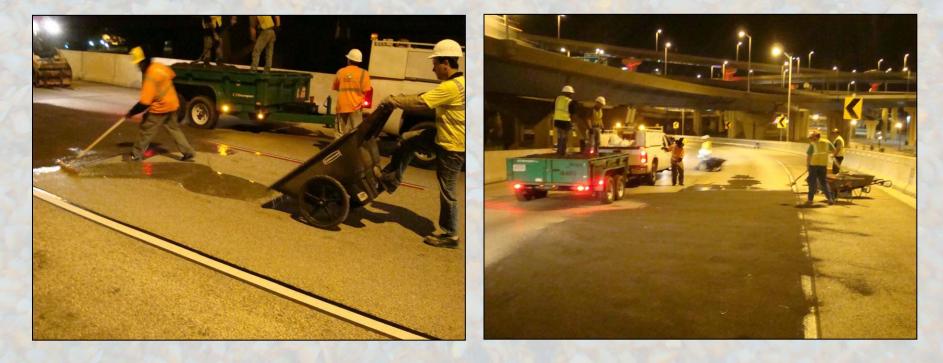
HFS Installation

- Manually
 - Manual mixing of epoxy material
 - Manual application of epoxy with squeegee
 - Hand broadcast and distribution of aggregate
 - Production rates: 165-420+ m²/hr (200-500+ SY/hr.)

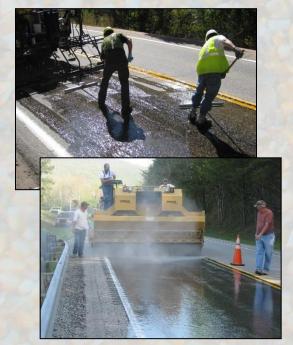
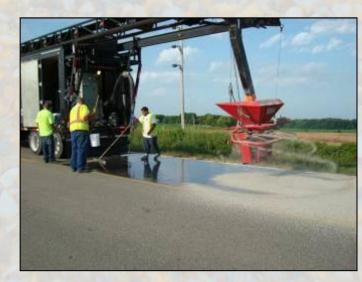
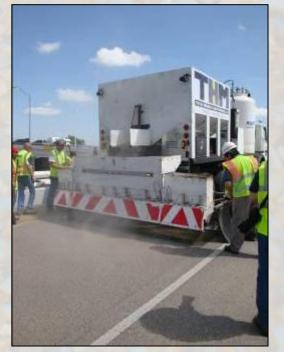
HFS Installation

- Automated (machine-aided)
 - Machine mixing and application of epoxy (limited hand/squeegee work)
 - Machine broadcast/application of aggregate
 - Production rates up to 1920 m²/hr (2,300 SY/hr.)

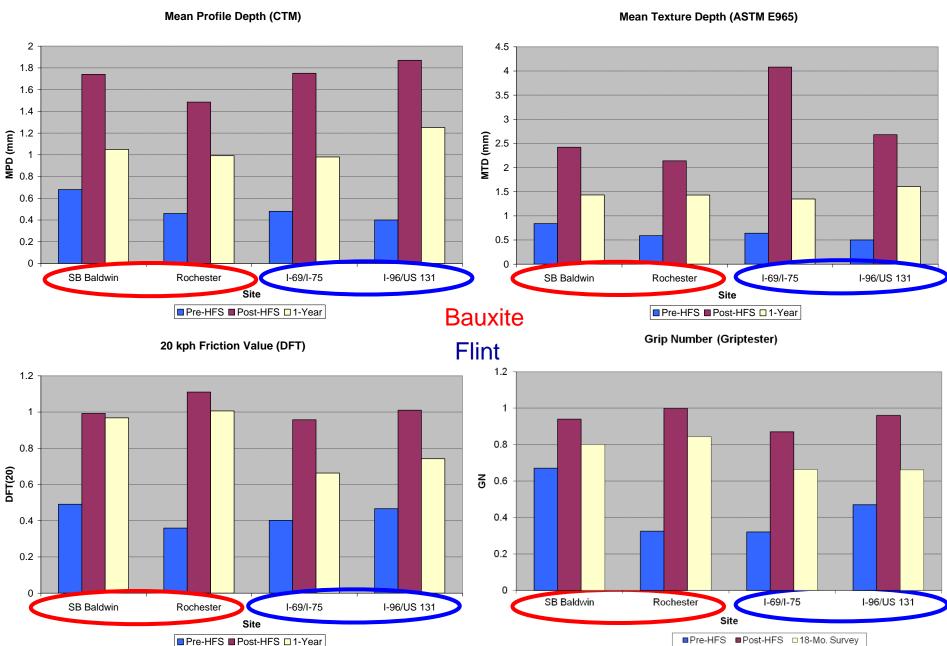
Michigan – PRELIMINARY Results

- HFS Vendor/Product: POLYCARB/SAFETYGRID
- Aggregate: Calcined Bauxite and Crushed Flint
- Projects:
 - NB I-75 to NB Baldwin Rd. ramp, Auburn Hills (PCC)
 - NB I-75 to Rochester Rd. ramp, Auburn Hills (HMA)
 - WB I-69 to SB I-75 ramp, Flint (PCC)
 - WB I-96 to NB US 131 ramp, Grand Rapids (PCC)

- Michigan
 - Site 1
 - 3 yr before: 26 crashes (8 wet)
 - 1 yr after: 4 crashes (1 wet)
 - Site 2
 - 3 yr before : 55 crashes (15 wet)
 - 1 yr after: 16 crashes (2 wet, 3 snow/ice)
 - Site 3
 - 3 yr before : 22 crashes (7 wet)
 - 1 yr after: 2 crashes (1 icy)
 - Site 4
 - 3 yr before : 25 crashes (12 wet)
 - 1 yr after: 3 crashes (1 wet, 1 icy, 1 alcohol)

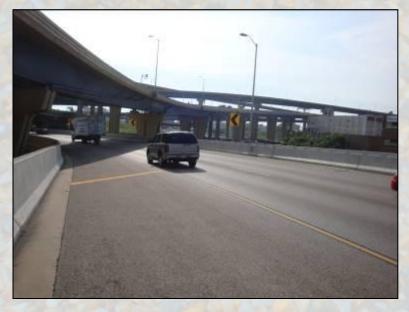
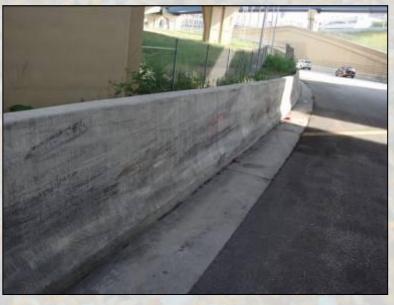
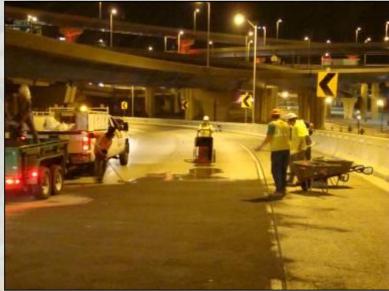
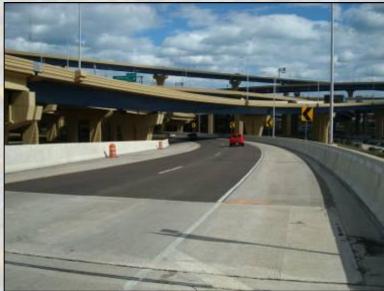
Wisconsin

- HFS Vendor/Product: Traffic Management USA / Safe-T-Grip
- Aggregate: Calcined Bauxite
- Projects:
 - EB I-94/I-794 to NB I-43 (Marquette Interchange W-N ramp)
 - SMA Pavement

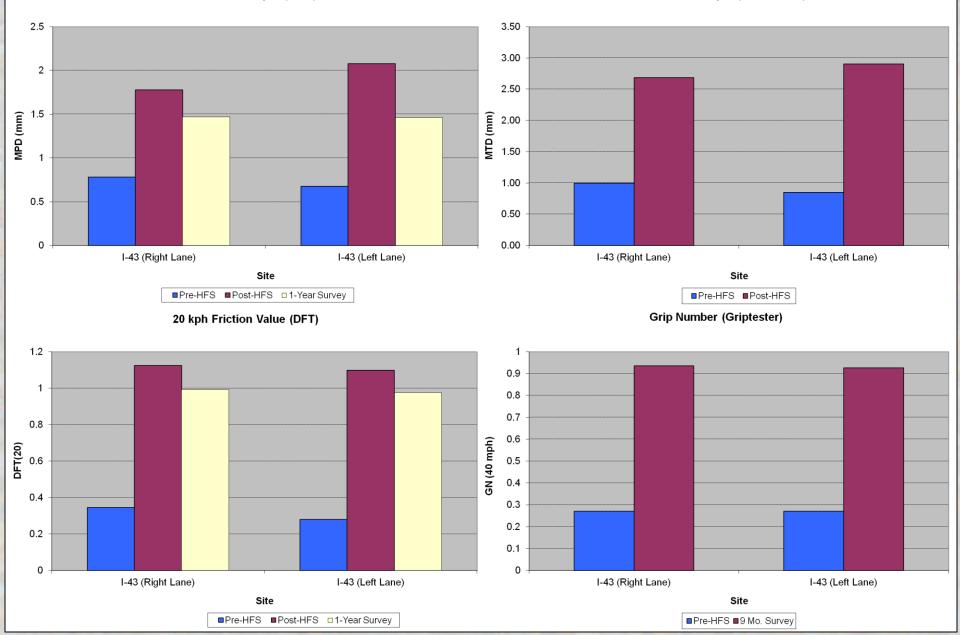
Wisconsin

Mean Profile Depth (CTM)

Mean Texture Depth (ASTM E965)

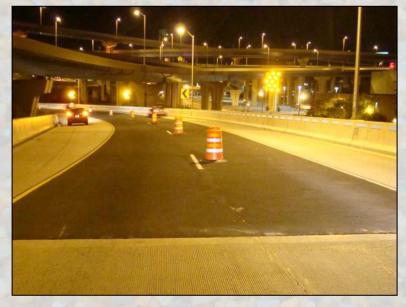
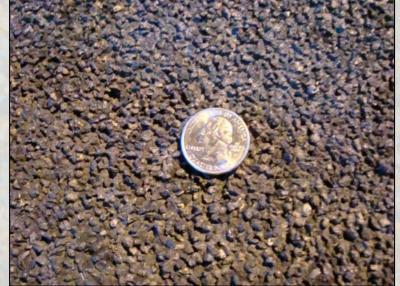
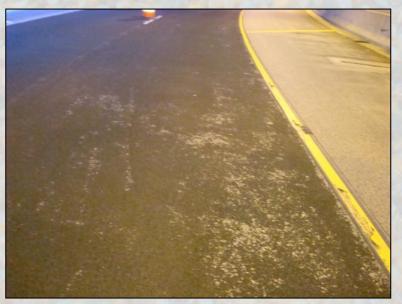
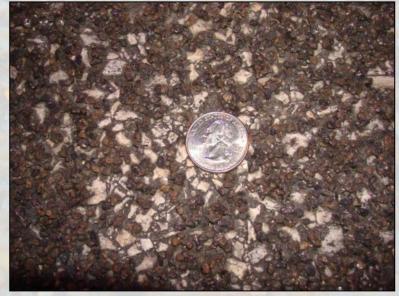
Wisconsin - performance

- Wisconsin Marquette Interchange W-N Ramp
 - "Ramp closed virtually every time it rains"
 - 2008-2010: 81 crashes (59 wet 73%; 2 icy 2%)
 - Since Sept. 2011: 2 crashes (dry conditions, driver inattention, truck lost control)

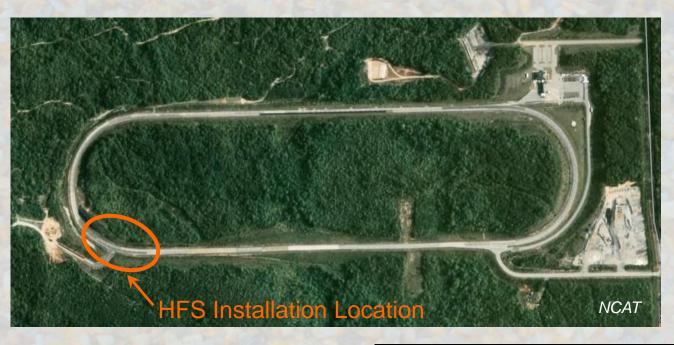
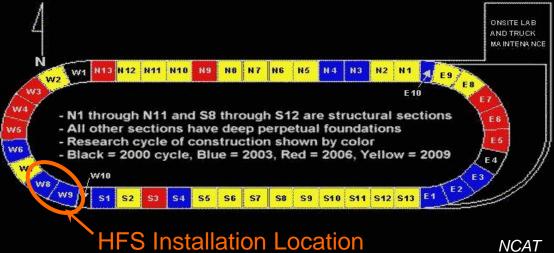
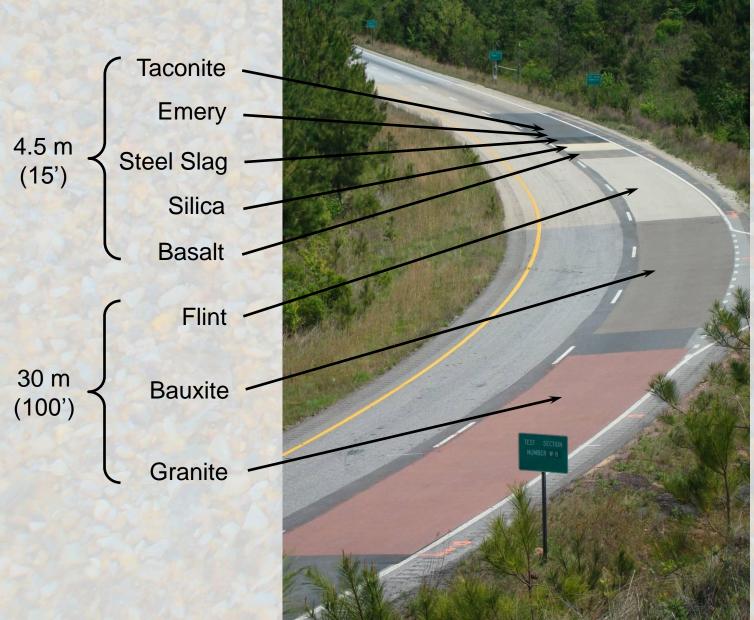
- Purpose: Test the durability of various aggregate types under the same conditions
 - Installed on similar sections NCAT Test Track on a curve
 - Installed by same HFS supplier using the same resin, crew, and equipment
 - Exposed to the same traffic and climatic conditions
- 2+ Million ESAL applications (April-October 2011)
- Laboratory Testing of smaller samples of each
- Aggregates Tested:
 - Granite, Bauxite, Flint: 30 m (100') each
 - Basalt, Silica, Steel Slag, Emery, Taconite: 4.5 m (15') each

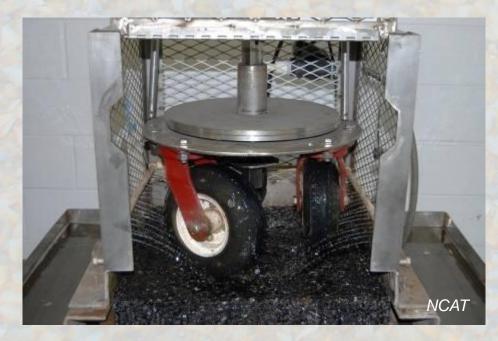
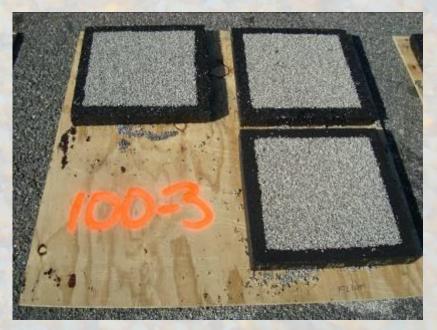
- Laboratory Testing
- Three Wheel Polishing Device
 - Friction and Texture tested at 70k and 140k cycles
 - 2 replicates for each aggregate type

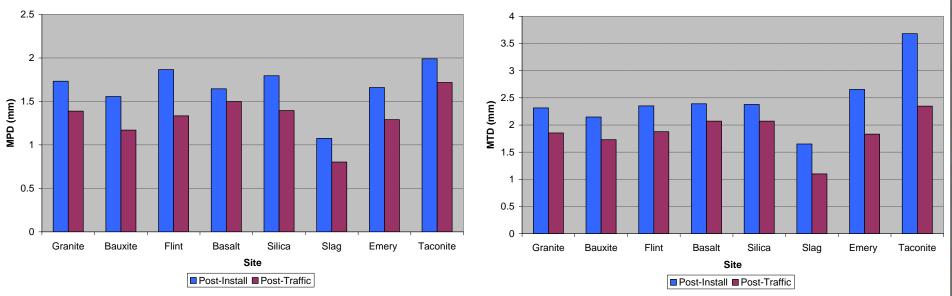
NCAT – PRELIMINARY Test Track Results

Mean Profile Depth (CTM)

Mean Texture Depth (ASTM E965)

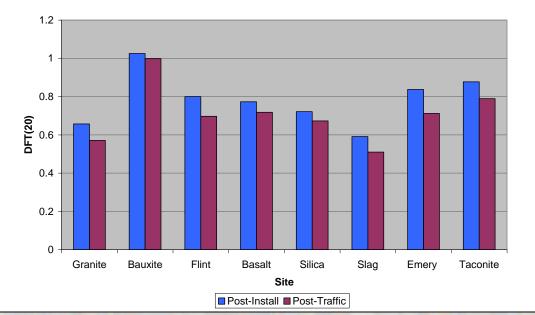
20 kph Friction Value (DFT)

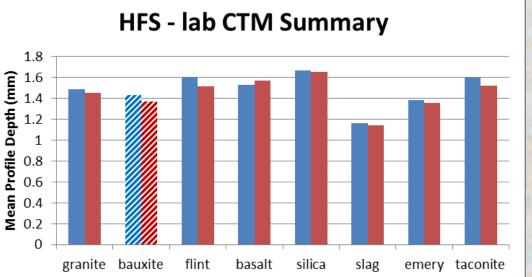
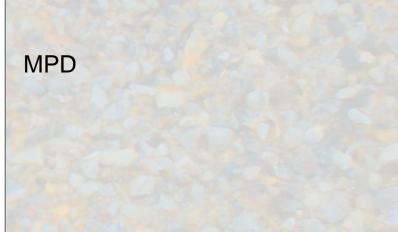
NCAT – PRELIMINARY Laboratory Results

■70K ■140K
