Pavement Evaluation 2014

September 15 – 18, 2014
Resource International, Inc.

GPR for Pavement Rehabilitation

Premature Pavement Failure

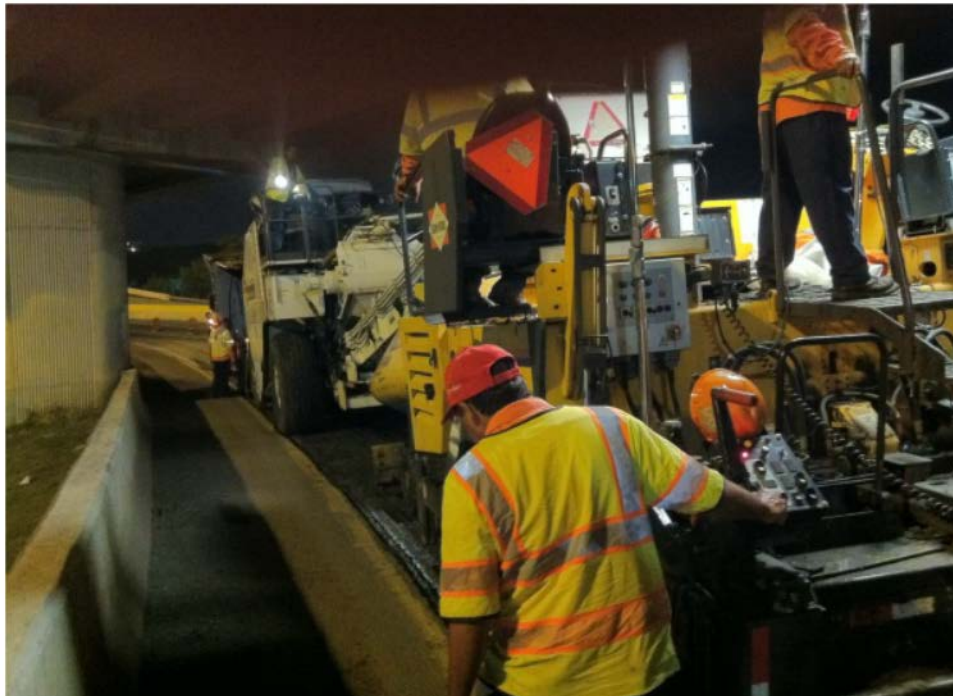
- Potholes were observed in lower elevation areas and at higher elevations such as on ramp embankments
- Many potholes appeared in wheel paths
- Potholes appeared to be depth of overlay
 - Overlay material appeared delaminated from the milled surface with loose material in the associated pothole
 - Distresses appeared consistent with stripping, either a cohesion failure between the aggregate surface and asphalt binder; or an adhesion failure within the asphalt binder itself.
- Project area is in coastal plane
- During rainfall event lower elevation areas showed evidence of ponding water in ditches.
